**CRASHED VEHICLE PROFILE CREATION BASED ON DIGITAL  
CLOSE-RANGE PHOTOGRAMMETRY****Valeria Ersilia Oniga\*<sup>1</sup>, Ana-Maria Loghin<sup>2</sup> and Daniela Corina Păun<sup>3</sup>**

**KEYWORDS:** close-range photogrammetry, vehicle profile reconstruction, 3D model.

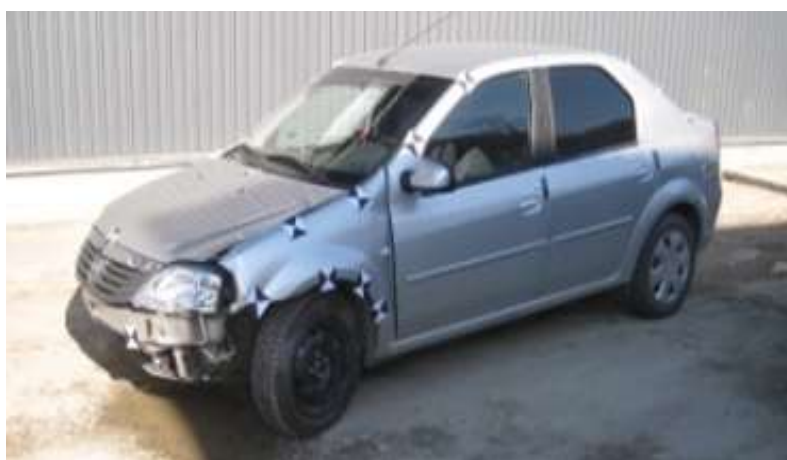
**Fig 3: Perspective view of the crashed “Dacia Logan” vehicle.**

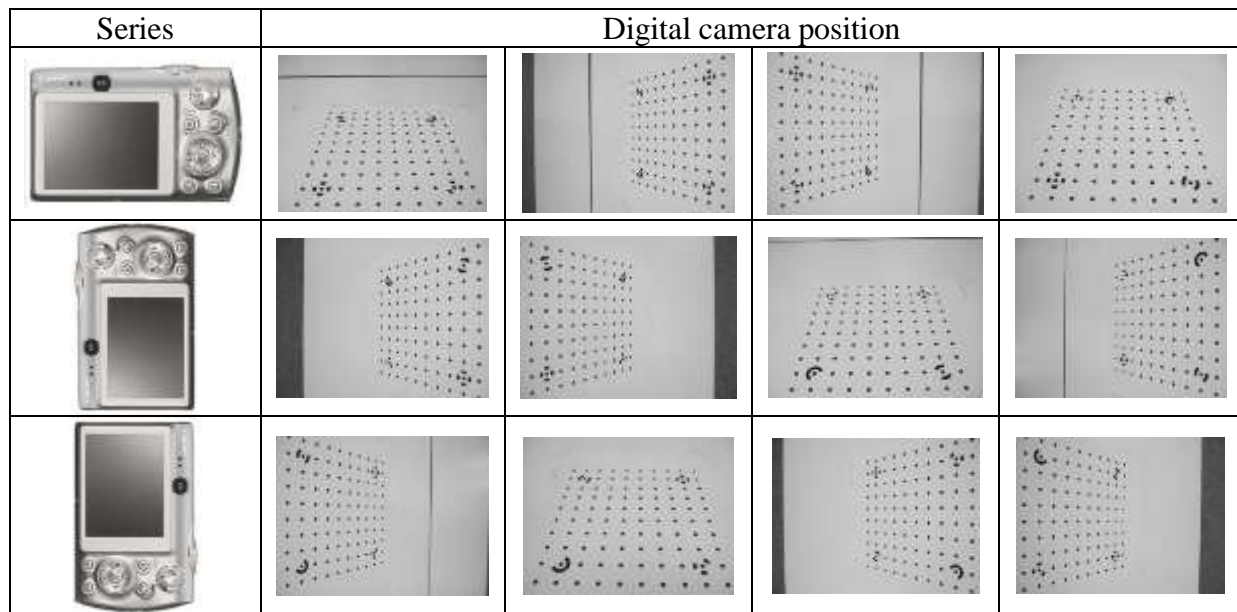
**Table 1: Calibration image capturing.**

This 2D calibration grid was printed on a A4 sheet of paper and then attached to a planar surface, preferably with un uniform texture and color, this fact leading to a reduced time of interior calibration parameter calculation. There were taken 12 images of the 2D calibration target, using 3 different positions of the camera, as it can be seen in the following table.

The twelve calibration images were imported into "PhotoModeler Scanner" software and the Camera calibration project was processed. Finally, the intrinsic parameters of the Canon Digital IXUS 960 IS camera were obtained, as can be seen in Table 2.

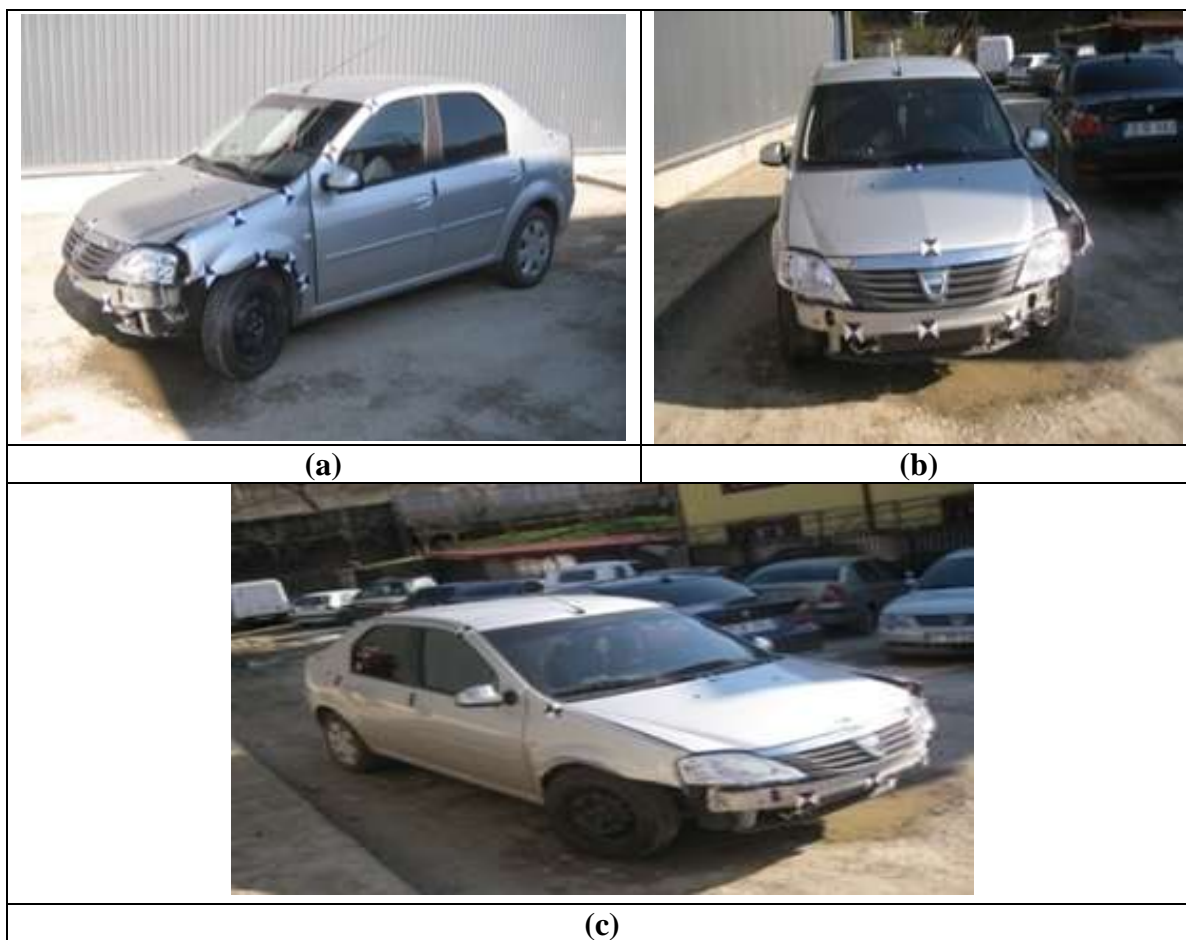
**Fig 5: Photo acquisition of the crashed Dacia Logan vehicle.**

**(a) left- side view; (b) frontal view; (c) right- frontal side view**

In order to generate the 3D model of the crashed vehicle, there was used a number of eight images taken with the same CANON IXUS 960 IS digital camera. These photographs were taken around the car, from different angles, with the interest object central located, having an overlap of about 25% to 60% (Fig. 5). As mentioned, the studied object has to be central located in the image, due to distortions that are higher in the margins. Also, in order to determine the 3D position of a detail point, this must be identified in a minimum of three photos. An important condition to be mentioned, is that each single photo of the "PhotoModeler Scanner" project must have six common detail points with the other ones.

From the resulted 3D model it can be seen that in the frontal part there are blue colored triangles, showing that negative distances with values of around 18 cm were calculated, which means that the bumper is missing. Also, on the left-side, there are red colored triangles, showing that positive distances with values of around 15 cm were calculated, the left guard being outwards distorted, as can also be seen in Fig. 5 b..

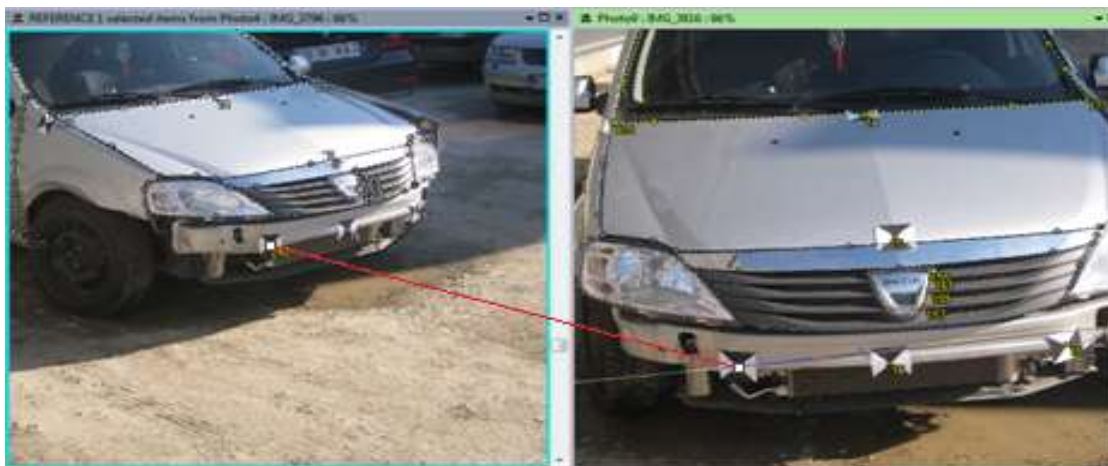
**Fig 6: Points correlation between images.**

The images were then imported into the “PhotoModeler Scanner” software and the manually match common features method was used. The detail points and lines together with the artificial targets placed on the vehicle body, were identified and correlated, using the “Reference Mode” software’s function (Fig. 6).

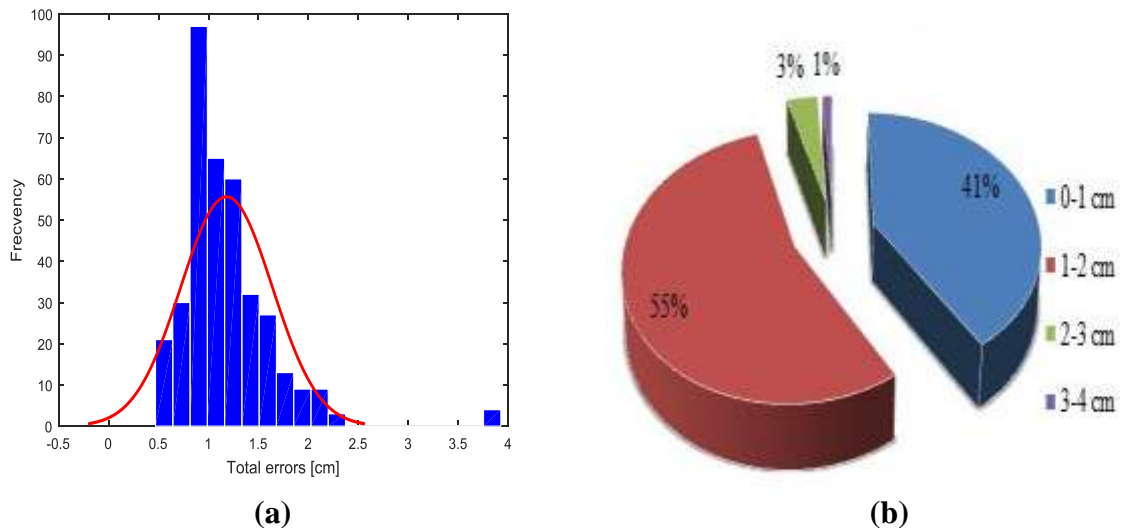
**Fig 9: (a) The total errors distribution histogram and (b) the error repartition of the measured detail points coordinates in world units.**

Second, the total errors for determining the crached vehicle detail points coordinates in world units were calculated. From the total error distribution histogram of the detail points coordinates (Fig. 9 a), it can be seen that the errors ranges between 0.5 cm and 3.9 cm (Oniga V. E., 2014). It was also realised the percentage of errors repartition of the detail points world coordinates, with an interval of 1 cm, that can be seen in Fig. 9 b.
