### ASSESSMENT OF SANITARY CONDITIONS AND LANDSCAPE DESIGN OF ALAGBAFO NATURAL SPRING, KUBE – ATENDA COMMUNITY, IBADAN

Dr. Oguntunde O. A.<sup>1\*</sup>, Sridhar M. K. C.<sup>2</sup>, Coker A. O.<sup>1</sup> and Oyelakin J. F.<sup>1</sup>

<sup>1</sup>Department of Civil Engineering, University of Ibadan, Ibadan, Nigeria.

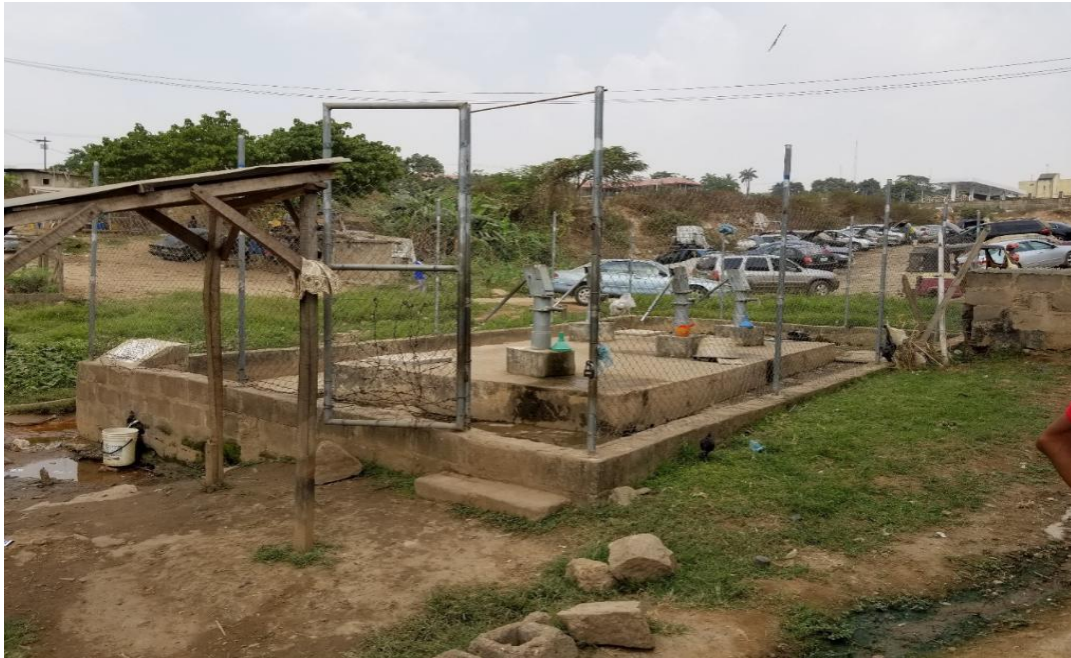
**Figure 2: Alagba Natural spring.**

Also, few artisans such as Welders, Carpenters, Cobblers, etc. are present in the community. There are also pockets of fertile grassland in the community where the residents' rear animals like goat, sheep, fowl, etc. and grow varieties of crops such as maize, pepper, vegetables and others (Onyemesim *et al.*, 2007). The topography of Kube-Atenda community can be described as generally flat due to the hilly nature of other areas surrounding it. The Alagbafo spring is located behind the Castle Inn, along the road leading downwards into the Kube-Atenda community. The spring is developed, it includes a reservoir which is protected and from which water is withdrawn with the aid of a mechanical hand water pump (Figure 2).

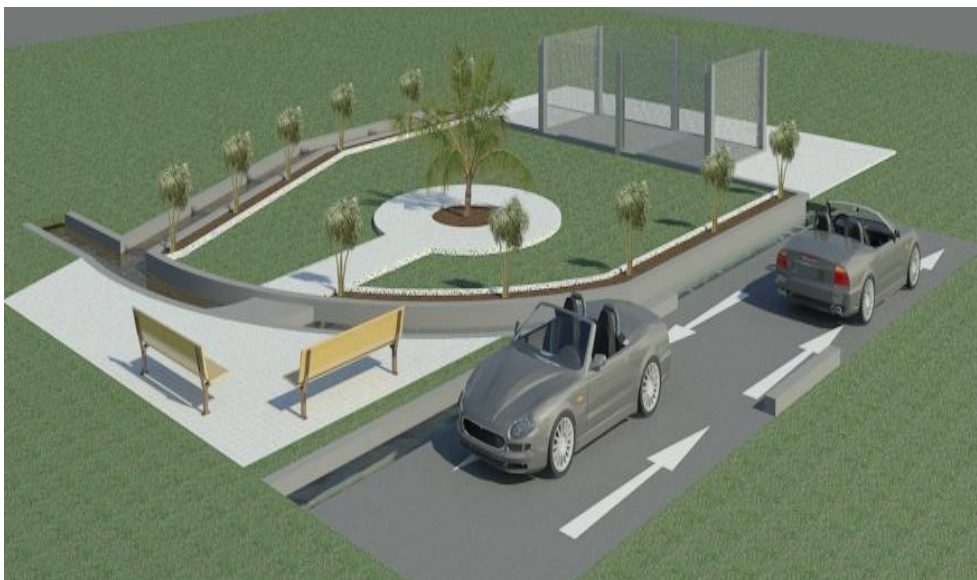
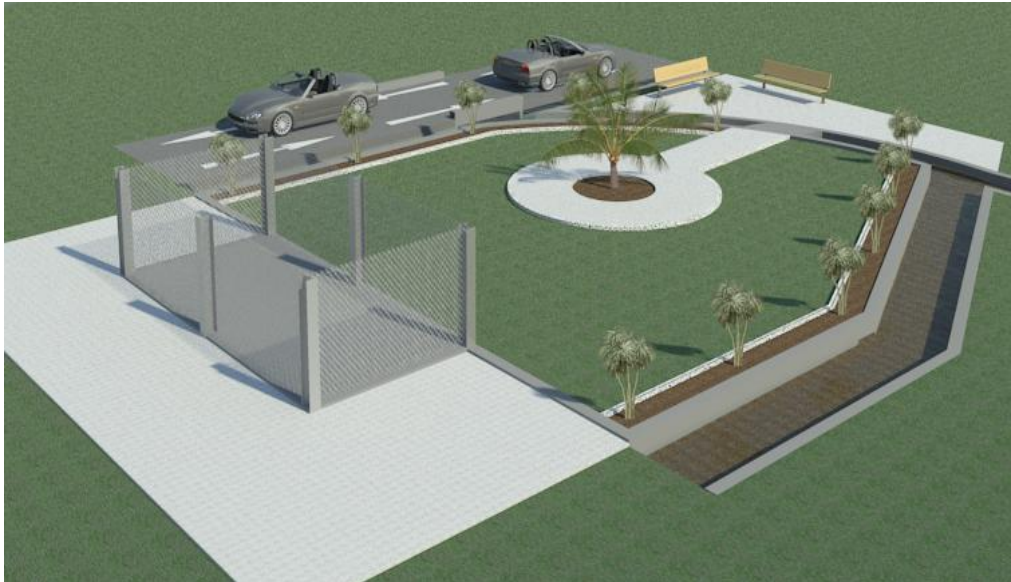
**Figure 4a: 3D Render side view of the Alagbafo Natural spring.**

- A. Improved block drainage channel
- B. Hardscape partition (flooring made of interlocks or granite stones)
- C. Alagbafo Natural spring
- D. Lawn grass (*Paspalumnotatum*)
- E. Tree to provide shade (*Lagerstroemia speciose*)

Flowers (*Rhoeo discolor* and *Wire croton*)
