**INVESTIGATION OF TRAFFIC ACCIDENT PRONE AREAS
RELATED TO EXISTING ROAD CONDITION AND DRIVER'S
BEHAVIOR ALONG MENAGESHA- AMBO ROAD SECTION**

*Eyob Mekonnen (MSc)¹, Prof. Emer Tucay Quezon² and Murad Mohammed (MSc)³

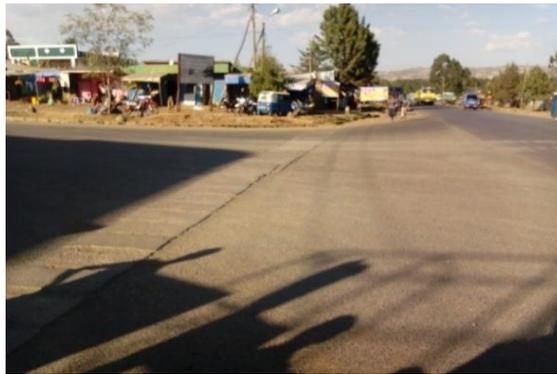
Figure 3.4: Gabriel Existing Road Condition

This location is found around Ethiopian road authorities size and weight control station. Its location is in town section. The countermeasure that should be applied on this road is: - Edge side and Central traffic marking should be painted. Also, Island should be provided in the intersection area. The sufficient pedestrian walking lane should be provided and also speed limit post should be installed.

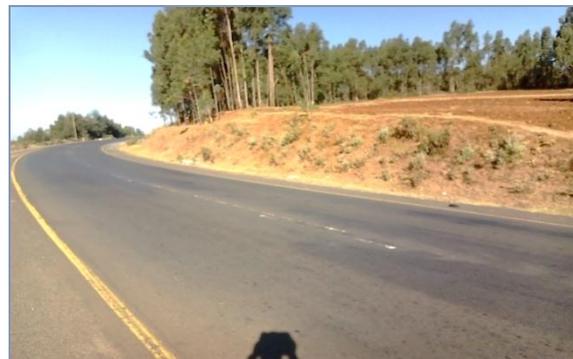
most stretch of the road configuration of Menagesha is covered with more than 13 horizontal curves and in connection with this; this road is a very congested type of road while viewing the traffic characteristics.

Figure 3.6: Menagesha Existing Road Condition.

The countermeasures that should be applied are: a) Pedestrian walking lane should be provided; b) The length between the curves is so small that it needs design revision, c) The centerline marking should be re-painted, d) Speed limit post should be installed, e) There are obstructions inside the curve, so that blockage should be cleared.

The countermeasures that should be undertaken: a) the lane width is not sufficient, so that it should be widened, b) There are Equilaptus trees surrounding the curve that obstructs the vision of the drivers, so that it should be cleared, c) There is a steep gradient along the road stretch so that speed limit posts should be installed along the road, d) There is already existing concrete roadside Delineator but it was damaged by accidents, therefore, repair should be done.

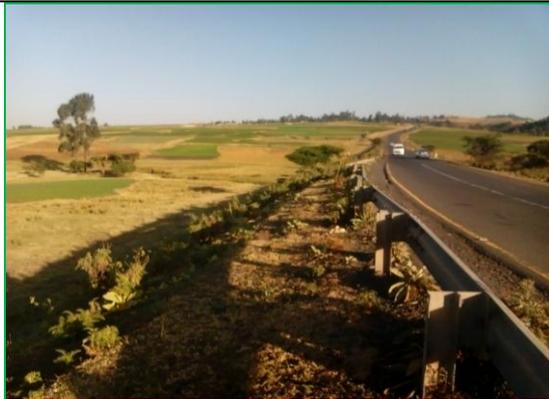
Fig 3.8: Wacan Mazoriya Existing Road Condition.

The countermeasures that should be undertaken are: a) Roadway width should be increased, b) proper guardrail should be installed, c) Climbing lane should be provided to assist the faster moving vehicles to pass, d) There is steep gradient, so that speed limit posts should be installed, e) Pavement marking is faded, so that it should be re-painted, f) There is the problem of Mis-phasing so that, the design should be reviewed.

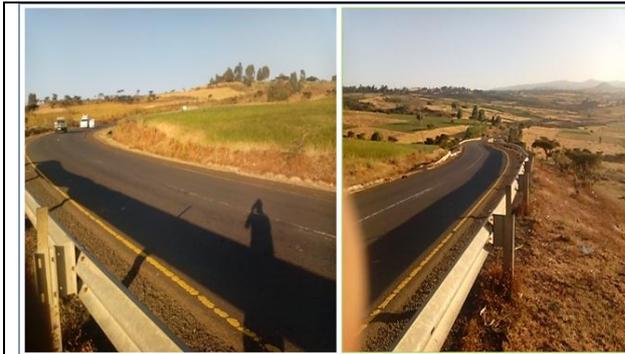
Figure 3.10: Minini Existing Road Condition.

The obstruction inside the curve, which obstructing the driver's vision must be removed. The existing guard rail is not functioning and sufficient along with the left side so that it should be re-installed, and Traffic signs are needed inside the curve.

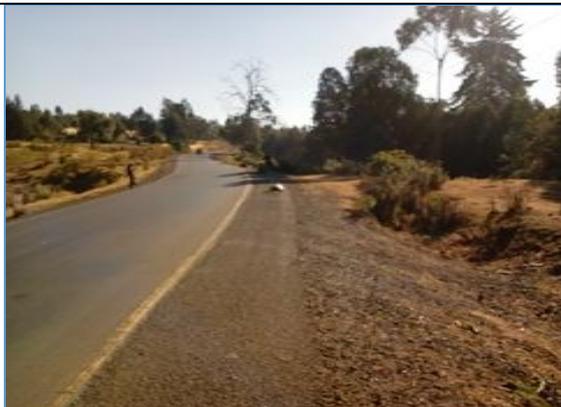
Figure 3.12: Chiri existing condition.

Obstruction near the curve should be removed (trees are around). Speed limit posts should be installed. Since the shoulder width is not sufficient should be increased. Road side Delineator should be installed along the road.
