## PROBLEMS AND CHALLENGES OF FLOODING IN YENAGOA CITY, NIGERIA

The aim of the study is to identify and assess the problems and challenges of flooding in Yenagoa City, Nigeria. The study adopted a multi-stage and simple random technique to administer and collect data for study. The study found that the city experiences flooding regularly due to unchecked development on wetlands fuelled by unplanned rapid urbanisation, weak development control practice, inadequate storm water drainage infrastructure, development along and within natural drainage paths and unsustainable waste management practices which all have given rise to environmental, health, social and health challenges. The study recommended that Yenagoa Masterplan, 2004 should be implemented, sustainable flood management framework should be prepared, non-structural and structural techniques should be employed where appropriate in the city.

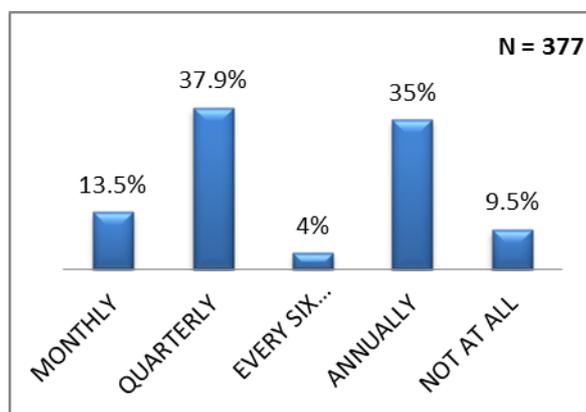
**Fig. 2: How Often Flooding Incidence is Experienced in the Communities**

The study revealed that Yenagoa City is prone to regular flooding every year as 37.9% of the respondents experience flooding quarterly, followed by 35% annually, 13.5% said monthly while 4% said every six month and 9.5% said not at all. This means that majority of the residents experience flooding every year (see Fig. 2). The flooding experienced by the residents in the study area is mostly caused by the absence of drainage system in most of the streets and communities. Most of the communities in the study area are not planned before development begins which has led to haphazard development. The flooding experienced in the study area has caused environmental, health and social problems. From Fig. 3, it shows that in respect of environmental challenge, 78.8% of the respondents said that it affects them very strongly, 42.8% said strong, 1.6% said fair while 3.4% said not strong and not strong at all, respectively. Fig. 4, reveals that in respect of health challenge, 54.1% of the respondents said it affects them very strongly, 27.8% said strong, 7.5% said fair, 8.8% said not strong and

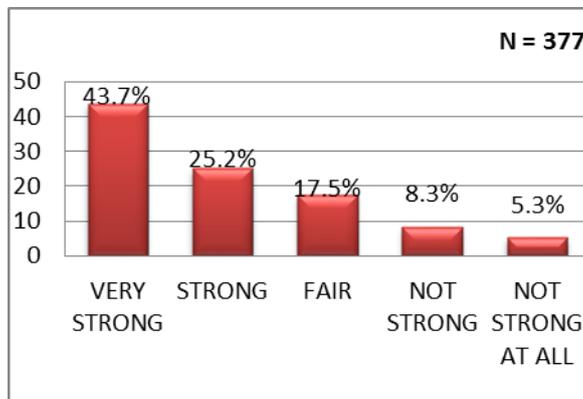
**Fig. 5: Social Challenge.**

1.9% said not strong at all. For social challenge, Fig. 5 shows that 43.7% of the respondents said it affects them very strongly, 25.2% said strong, 17.5% said fair while 8.3% and 5.8% said not strong and not strong at all, respectively. From Fig. 6 and Table 2, it is recorded that, as most of them are civil servants, economic challenges are not that much affecting on the residence. All these challenges mentioned are caused by the failure of the poor drainages available in streets and communities. This has caused contamination of water bodies in the city such as the Ekole, Epie, Yenagoa, Amarata, Azikoro, Biogbolo Creeks, the Ox-Bow Lake and other natural water bodies in the study making the fresh water undrinkable and use for other domestic uses.

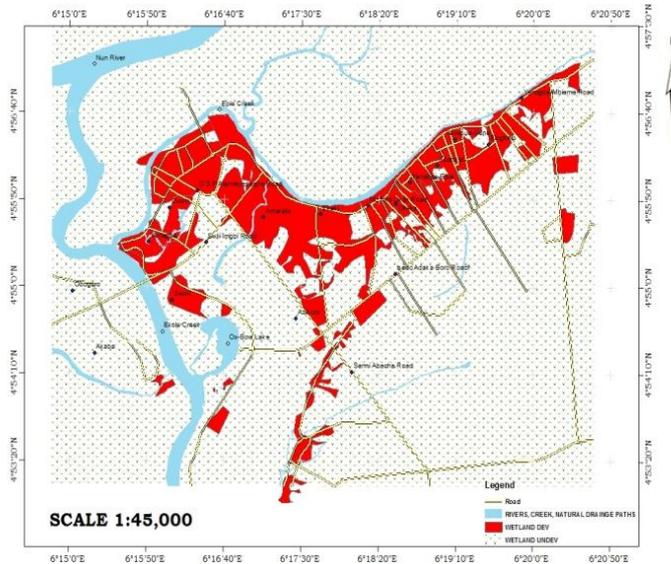
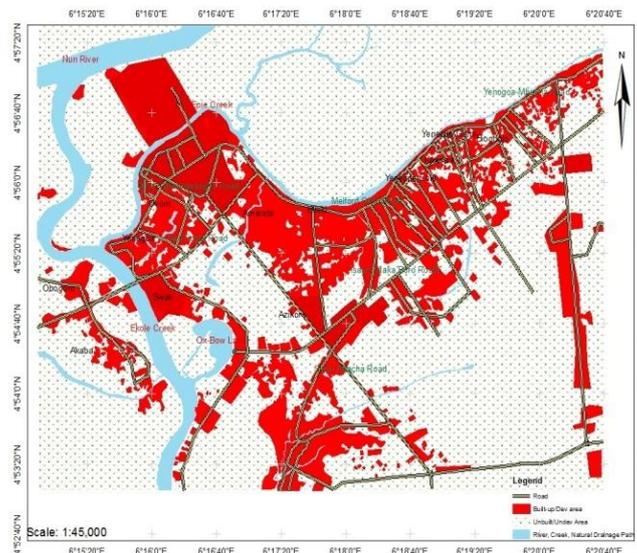
**Fig. 7: Extent of Urban Growth and Development of the Study Area at 2010.**

Most of access roads in the study area are not well laid out and designed to be provided with drainage beside them to collect and drain water from the streets during and after rainfall. Even the drainage of some streets is not well channelled to the natural drainage paths. It is also observed that people are developing close to the natural drainage paths without proper setbacks narrowing these paths. The intensive development in wetlands is increasing the level of densification in the communities and reducing the wetlands that are supposed to be conserved to serve its natural function of water retention. From the satellite imageries, it is found that the level of urbanisation is increasing yearly. Table 3 shows the level of change in urban growth between 2010 – 2016. It indicates that about 946.32 hectares have been developed upon between this period and some of these areas are within the identified wetlands. There is no concrete plan to manage and control the level of urbanisation in the city to achieve sustainable urban growth and development (see Figs. 7, 8, 9 & 10).

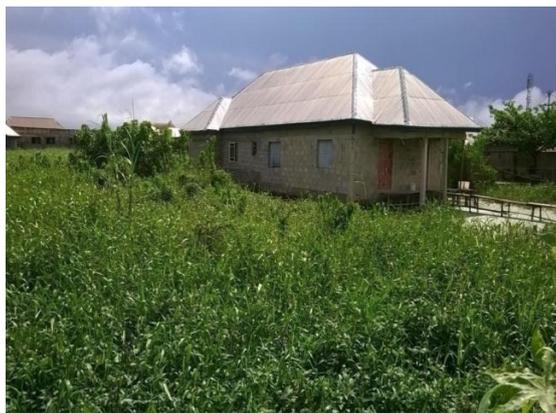
**Fig. 9: An Environmentally Sensitive Area (Wetland) not Planned Earmarked as Central Business District at Swali.**

Moreover, people have developed close to and along natural drainage systems without proper setbacks, thereby narrowing their paths of flow of storm water during rainfall. Some of the wetlands, identified in the study area, that are serving as natural retention ponds and river basins are being invaded by residents for urban development without considering their conservation and preservation. This is common in Azikoro, Swali, Biogbolo, Amarata, Ovom and Ekeki Communities.

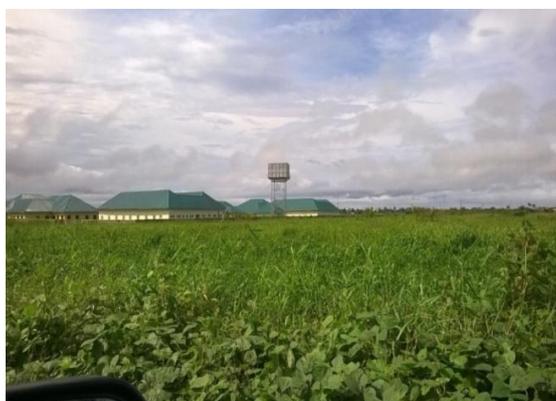
**Fig. 10: Wetland Occupied by Residential Buildings at Swali**

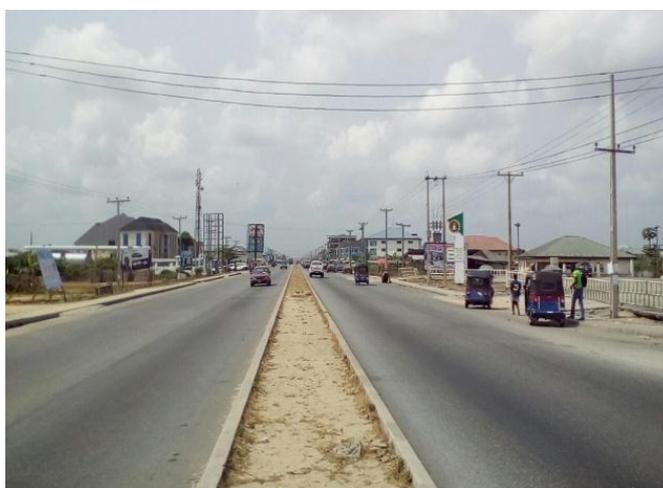
**Fig. 11: Isaac Adaka Boro Road without Drainage in the Study Area.**

Another factor causing flooding problems and challenges in the study is that all the major roads in the city do not have drainage systems for collection of storm water during rainfall. These roads include Melford Okilo, Yenagoa-Mbiama, D.S.P. Alamieyeseigha, Isaac Adaka Boro, Sani Abacha and Swali-Imgbi Roads. They are elevated and paved higher than the abutting properties along them. This impedes collection and free flow of storm water during and after rainfall. Also, some local streets in the study area have a similar problem of no drainage as 15.7% of the respondents attest to this reason (see Table 4 & Fig. 9).

It was also discovered that the government is not properly financing the storm water management infrastructure development in the city to solve the reoccurring incidence of

flooding (see Table 4 & Fig. 11). Most of the drainage canals are not de-silted by the government agencies and are clogged by refused dumps and sediments. Most of the road-side gutters and storm water drainage canals are not effective in evacuating runoffs from the built-up areas.
