EVALUATION OF LEVEL OF NON – MOTORIZED TRANSPORT (NMT) INFRASTRUCTURE ACCESSIBILITY, SAFETY AND ENVIRONMENT ON SELECTED ROADS IN KAMPALA CITY – UGANDA

Joel Mubiru^{*1}, Lawrence Muhwezi² and Rodgers. B. Mugume³

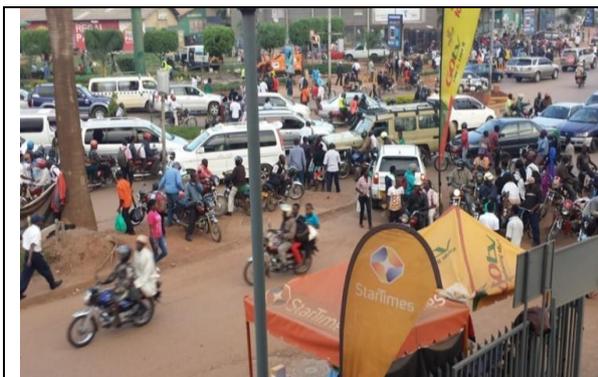
Figure 1: Traffic Mix at Shoprite Road Junction

Kampala experiences a comparably high motorization rate. Of the 80,000 vehicles registered countrywide (excluding motorcycles), over 60% are concentrated in Kampala which only covers 0.083% of the total land area in Uganda. The vehicle ownership is estimated to be about 15 cars for every 100 people which is far higher than the country`s average of 2.4 per 100 people.^[1,2] This makes it hard for pedestrians to use the road space due to a number of hindrances such as; high traffic jams during peak hours; high levels of traffic mix and sharing of road space between cars, pedestrians and “Bodabodas” (Fig.1) hence making the walkways inaccessible and unsafe.

Furthermore, the lack of appropriate infrastructure, poor crossing facilities and the presence of obstructions along the roads often forces pedestrians to walk on the carriageway, which makes them even more vulnerable to accidents. On roads where there are no raised walkways like Kisenyi road and Sir Apollo Kagwa Road (Fig.2), pedestrians have to walk on the road shoulders, making them vulnerable to other road users who often use the same shoulders as well, especially “bodabodas” and pedal cyclists.

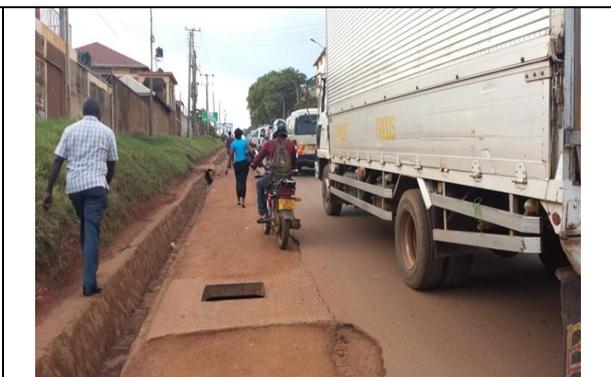
Figure 2: Pedestrian walking across an open drain along Sir Apollo Kagwa Road

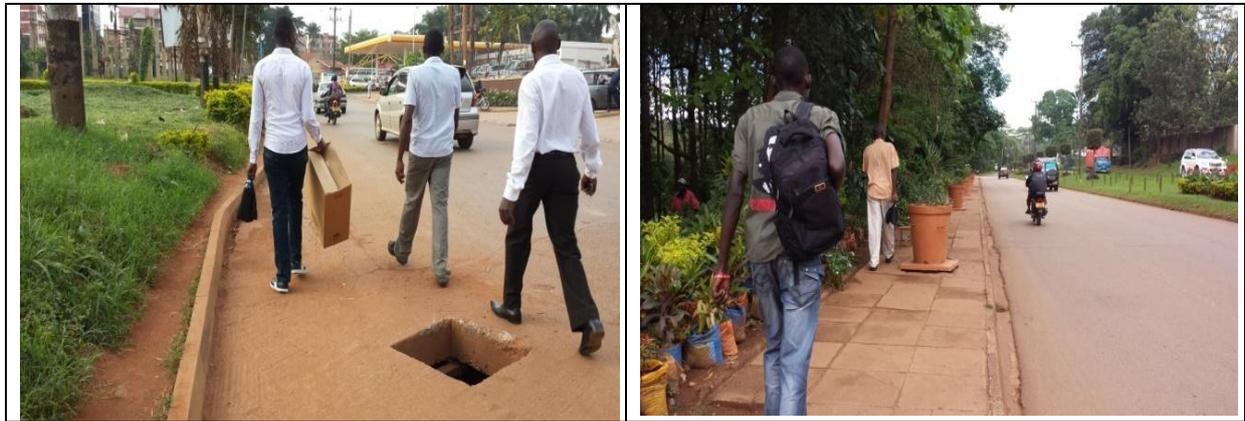
Figure 3: Risky open manhole along Luthuli Avenue and flower pots along Yusuf Lule Road.

Another challenge of walking at night are attacks from thugs and pickpockets on the streets, especially when it is dark. Lastly open manholes that are not attended to have also left a number of pedestrians injured (Fig.3). Though KCCA has tried a number of times to close them, manhole covers have always been stolen. KCCA has now come up with an innovative way of covering manholes though by use of concrete flower pots though this technique compromises on the space of the walkways.
