THE EFFECT OF EXPOSURE TO COASTAL CLIMATE ON DURABILITY OF LOW-RISE BUILDING ENVELOPES IN NWC (NORTH WEST COAST) RESORTS

Ehab F. Rached^{1*} and Azza S. Wahba²

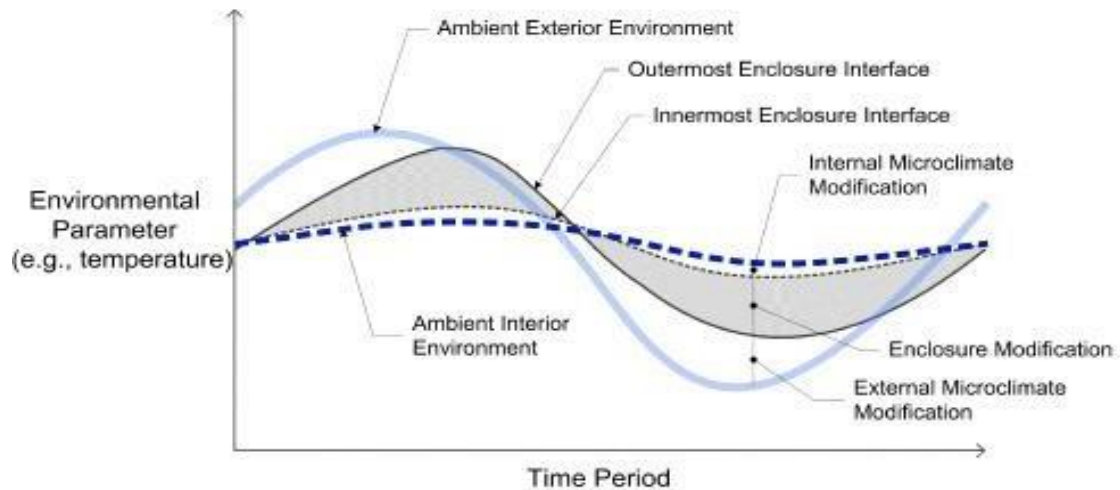
Fig. 4: Contributors to environmental modification.^[16]

While the enclosure may be the largest modifier, the difference or the modification between the ambient and interface conditions can also be significant. Note that the scale of Fig.4 will be different for different parameters. Moreover, this simple representation of variation over one cycle of time for one parameter does not accurately or fully represent the complex behavior and interactions that occur. The properties of exterior environments and microclimate environments are separate and major fields of study.^[16-22]

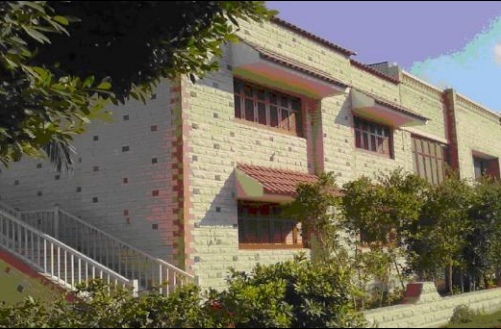
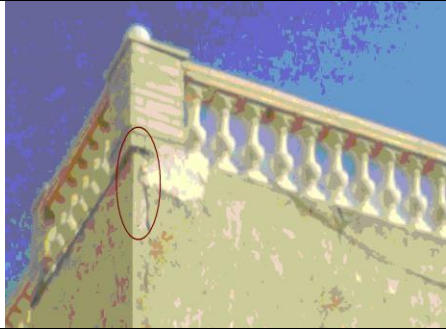
Location		Condition and Deterioration features of finishing materials in relation to Building Orientation: Comparison between (Stone / Brick Veneer vs. Rough Render Finish)			
		Stone /Brick Veneer	Render Finish	Damage	
1 st Row	<p>Exposure: Average Orientation: South – South West Facades</p>			Type	Source

Heat	Solar Radiation	
	<p>• Condition:</p>	<p>• Condition:</p>			
	<p>- Cladded parts of the wall were found in a very good condition</p>	<p>-Render finished Southern walls : Cracks at corners due to thermal expansion in non- cladded buildings - loss of Pigmentation due to UV Radiation</p>			
	<p>Exposure: High</p>	<p>Orientation: Western Facades</p>

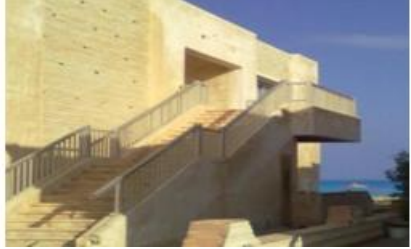
<p>Exposure: High– 1st Row-</p>

<p>Orientation: Eastern Facades</p>

<ul style="list-style-type: none"> Condition: <p>- Cladded parts of the wall were found in a very good condition.</p>	<ul style="list-style-type: none"> Condition: <p>-Render Finished parts of the wall were found in fair condition</p>		
	<p>Exposure : 1st row</p>

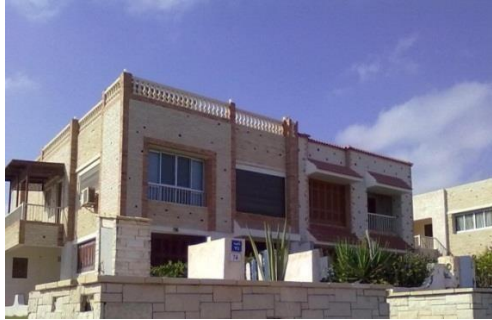
<p>Orientation :North – North East</p>

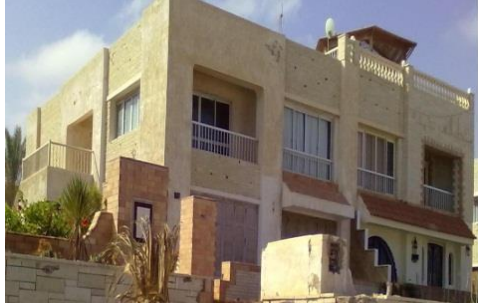
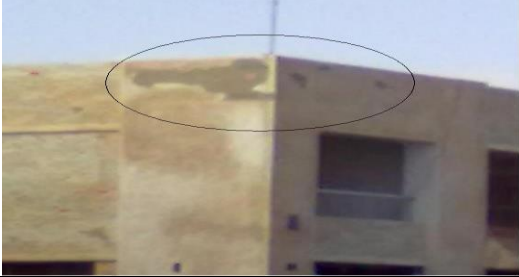
Heat	
	<ul style="list-style-type: none"> Condition: <p>- Cladded parts of the wall were found in a very good condition.</p>	<ul style="list-style-type: none"> Condition: <p>-High moisture content in corner parapet wall caused partial peeling in wall render finish due to water ingress at the intersection line between the roof slab and the wall. (Moisture carried by high wind velocities, together with probable accumulation of rain water.)</p>		
2nd Row	<p>Exposure: Average : 2nd row</p> <p>No Samples were found for this orientation</p>	<p>Orientation- Southern Façade</p>

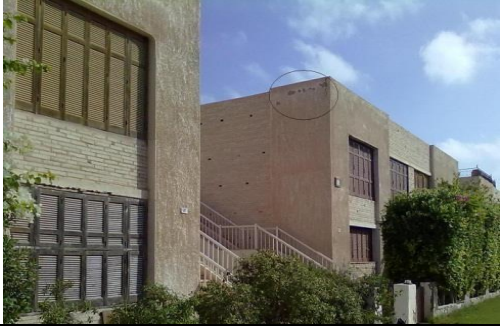
Moisture	Driving Rain

<ul style="list-style-type: none"> Condition: <p>High moisture content in corner parapet wall caused partial peeling in wall render finish due to water accumulation on the roof surface and absorption at the intersection line between the roof slab and the wall.</p>		
	<p>Exposure:High:2nd Row: Walkway</p>	<p>Orientation: Western Façade</p>

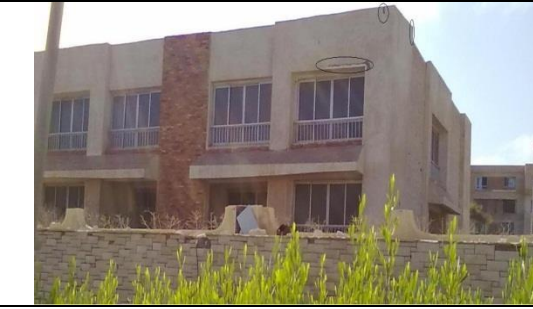
• Condition: - Limestone and brick Cladded parts of the façade (including corners) were in a very Good Condition	• Condition: Main damages in Rendered parts are : -Corner cracks in parapet wall and -Partial fracture in the concrete cover of window sills -Partial Peel off of render finish	
Table 3 : *(Source: The Researcher)
