**CRASHED VEHICLE PROFILE CREATION BASED ON DIGITAL  
CLOSE-RANGE PHOTOGRAMMETRY****Valeria Ersilia Oniga<sup>\*1</sup>, Ana-Maria Loghin<sup>2</sup> and Daniela Corina Păun<sup>3</sup>**

**KEYWORDS:** close-range photogrammetry, vehicle profile reconstruction, 3D model.

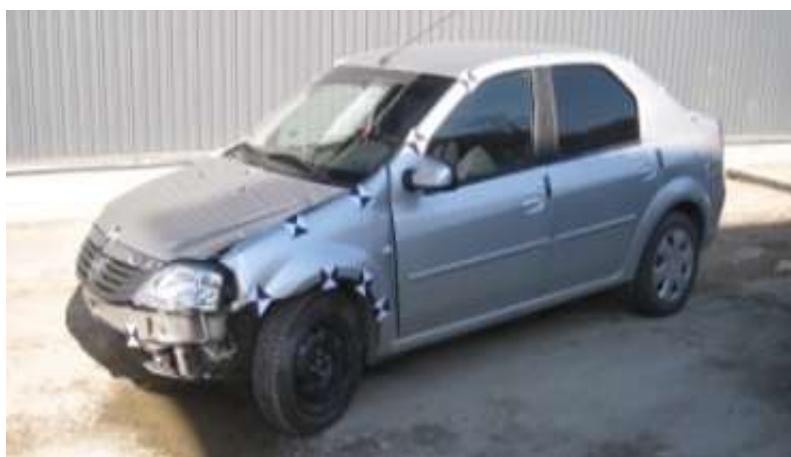
**Fig 3: Perspective view of the crashed “Dacia Logan” vehicle.**

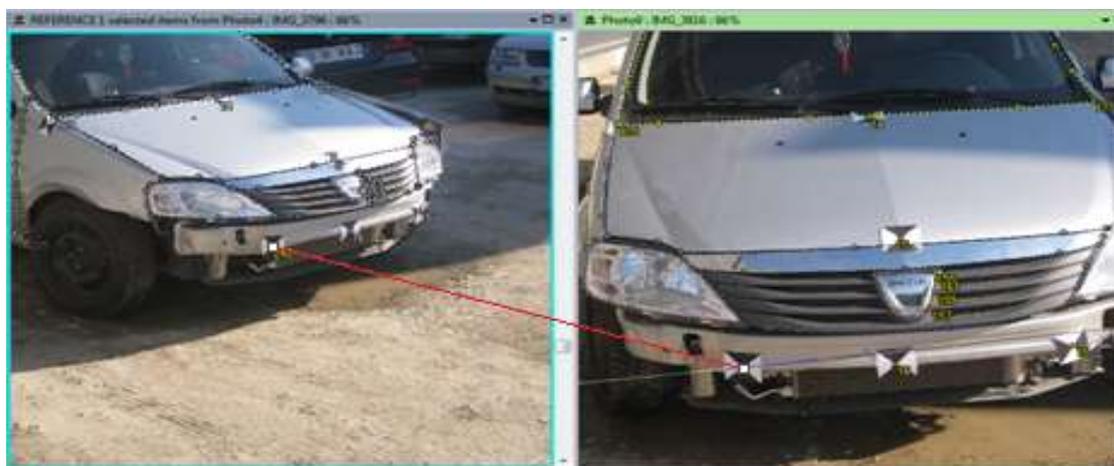
**Fig 6: Points correlation between images.**

The images were then imported into the “PhotoModeler Scanner” software and the manually match common features method was used. The detail points and lines together with the artificial targets placed on the vehicle body, were identified and correlated, using the “Reference Mode” software’s function (Fig. 6).

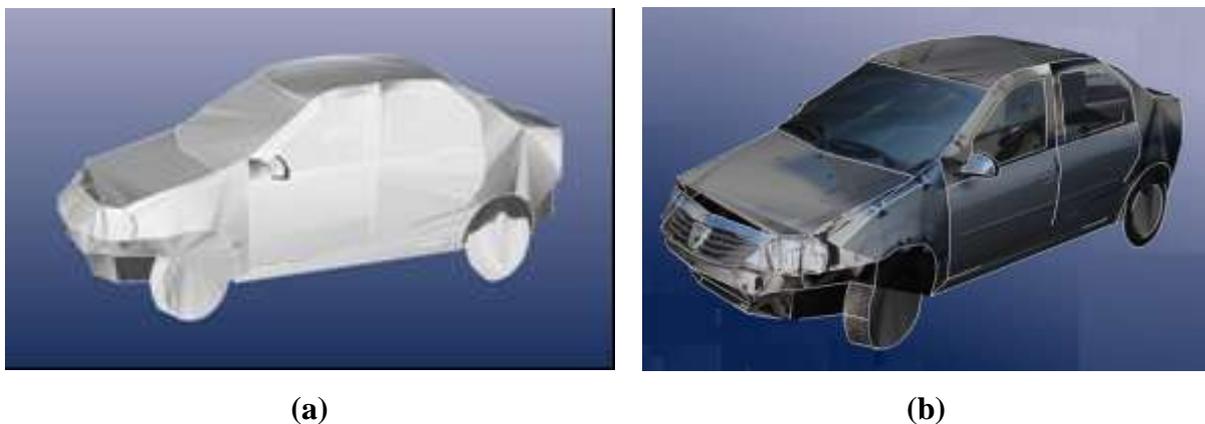
**Fig 7: The 3D model of the Dacia Logan crashed vehicle, created in “PhotoModeler Scanner” software (a) with surfaces and (b) with textures.**

After the correlation process, the entire project was processed and the three-dimensional coordinates of 370 characteristic points of the crashed vehicle were calculated based on a number of eight digital images, as well as the exterior orientation parameters for each camera position. Using points, lines and curves, the 3D model of the crashed vehicle was obtained. As the 3D model was created in a local coordinate system at an arbitrary scale, the scaling process was necessary. So, a reference distance was measured, namely the distance between the central points of the car wheels from the same side of the vehicle. The final 3D model can be visualized with the created surfaces or in a textured mode, using the software's high-quality option (Fig. 7).
