ASSESSMENT OF SANITARY CONDITIONS AND LANDSCAPE DESIGN OF ALAGBAFO NATURAL SPRING, KUBE – ATENDA COMMUNITY, IBADAN

Dr. Oguntunde O. A.^{1*}, Sridhar M. K. C.², Coker A. O.¹ and Oyelakin J. F.¹

¹Department of Civil Engineering, University of Ibadan, Ibadan, Nigeria.

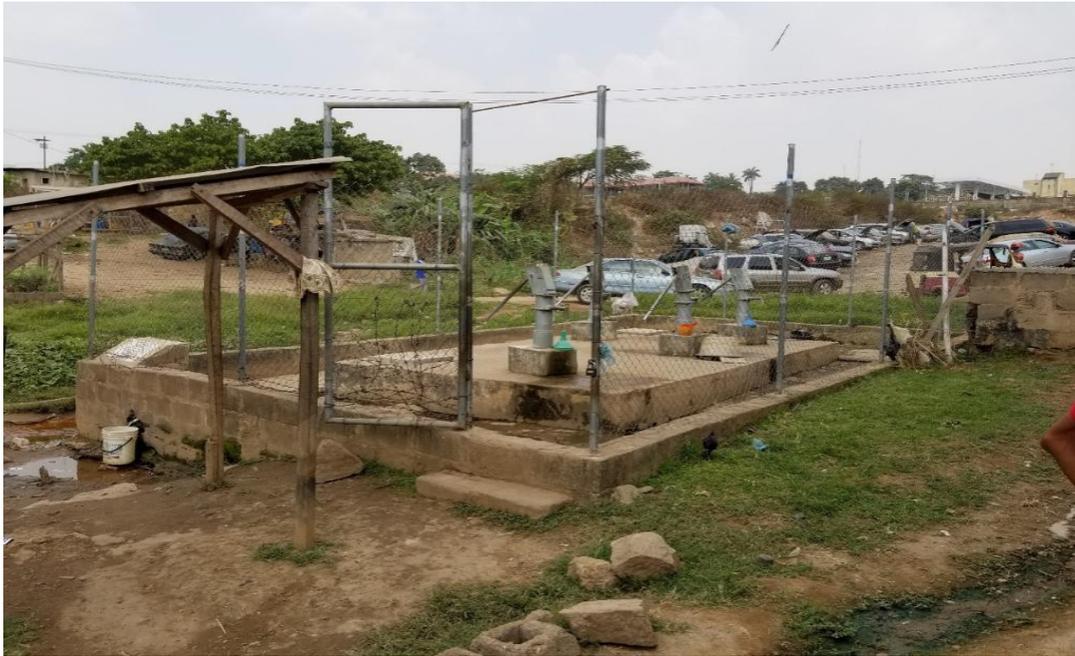
Figure 2: Alagba Natural spring.

Also, few artisans such as Welders, Carpenters, Cobblers, etc. are present in the community. There are also pockets of fertile grassland in the community where the residents' rear animals like goat, sheep, fowl, etc. and grow varieties of crops such as maize, pepper, vegetables and others (Onyemesim *et al.*, 2007). The topography of Kube-Atenda community can be described as generally flat due to the hilly nature of other areas surrounding it. The Alagbafo spring is located behind the Castle Inn, along the road leading downwards into the Kube-Atenda community. The spring is developed, it includes a reservoir which is protected and from which water is withdrawn with the aid of a mechanical hand water pump (Figure 2).

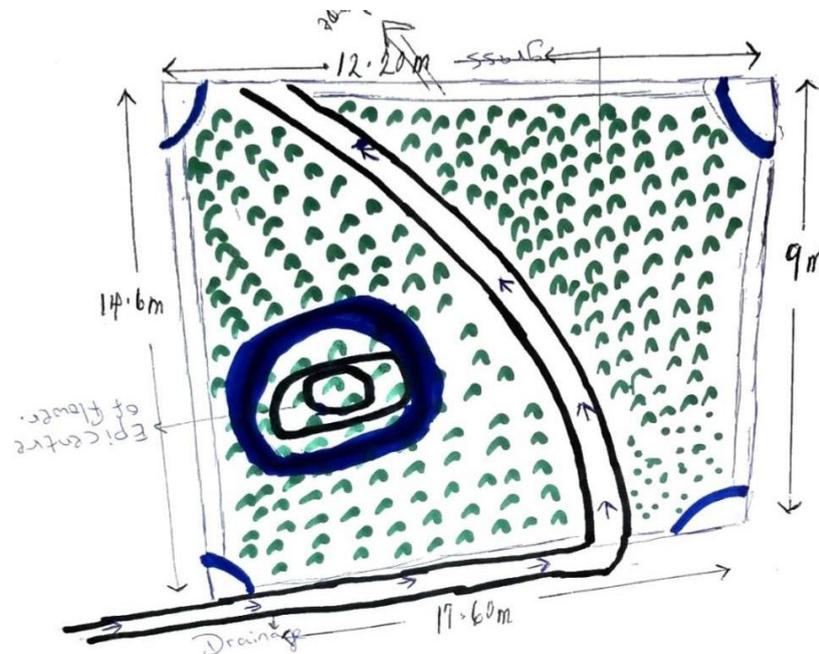
During the duration of carrying out site analysis, a free hand sketch was replicated on an A4 paper (Plate 1) showing the base plan of the area to contain the landscape. This sketch was then colour with available writing materials present. The sketched design is indicated to be simple, as the landscape around the spring would be accessed by the community. The sketched design includes an improved channel for drainage of rainwater runoff, the whole area is indicated to be grassed as shown by the colour of the marking (green) in Plate 1. The blue coloured arcs marking around the base plan edges indicates the presence of flowers and the blue coloured sphere form indicated flower presence. The pale blue marking around the

sketch indicated the boundary. Although provision for hardscape (i.e. paved areas and walkway) was not made on the conceptual design, it was taken into account to be included at the final design which was done with the aid of a computer program called Revit 2016.

Plate 1: Concept Sketched design for Landscape.

The conceptualized landscape gives the plan view layout of the site with an improved channel for drainage of rainwater runoff and excess water. This sketch design served as base upon which the final design was done with aid of Revit 2016 software on the computer. The final design provides a beautiful layout to display the drainage channel, placement of flowers and tree with a circular theme of hardscape (paved floor) around the centre of the landscape design which is contain the presence of a tree.

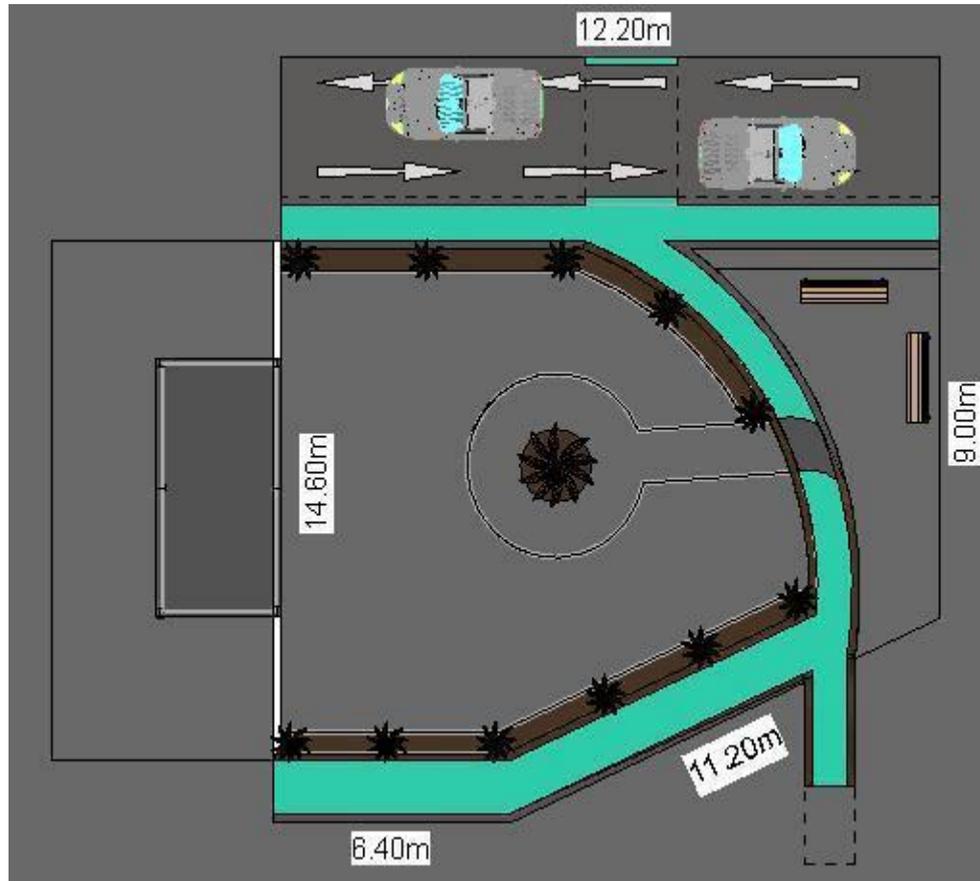
Based on the conceptualized design, a suitable design was developed using Revit 2016 software on the computer to produce a more aesthetic appearance. These designs are shown in Figures 3, 4 and 5. The designs reflect dimension sizes, improved sloped channel for drainage of rainwater runoff. Hardscape such as walkway, paved area and park chair are

included, grasses, flowers and a tree at its centre are shown with the Alagbafo natural spring as its reference. Conceptualized design and on-site photograph were used as data to help create a 3D render for the design.

Figure 3: Plan view with dimension.

- A. Improved block drainage channel
- B. Hardscape partition (flooring made of interlocks or granite stones)
- C. Alagbafo Natural spring
- D. Lawn grass (*Paspalumnotatum*)
- E. Tree to provide shade (*Lagerstroemia speciose*)

Flowers (*Rhoeo discolor* and *Wire croton*)

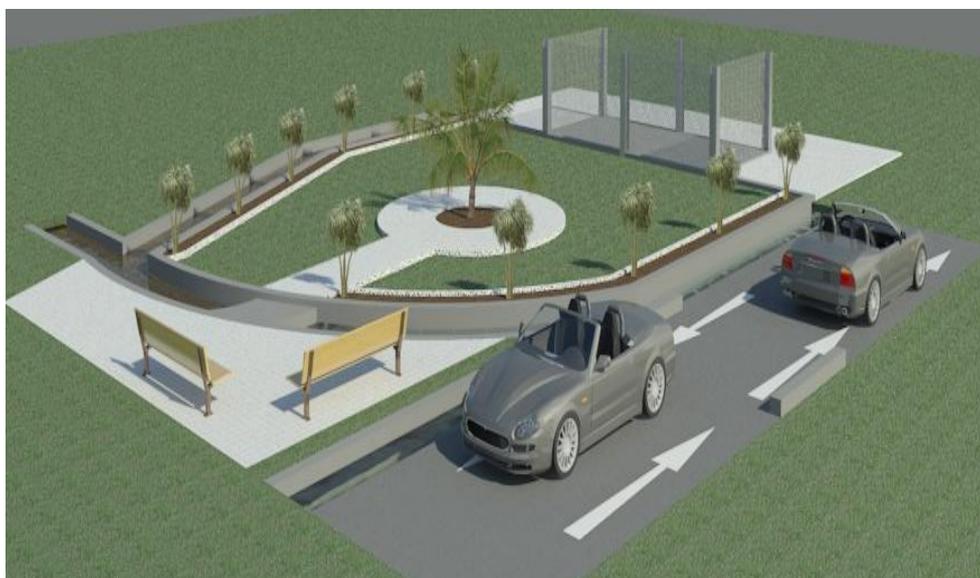
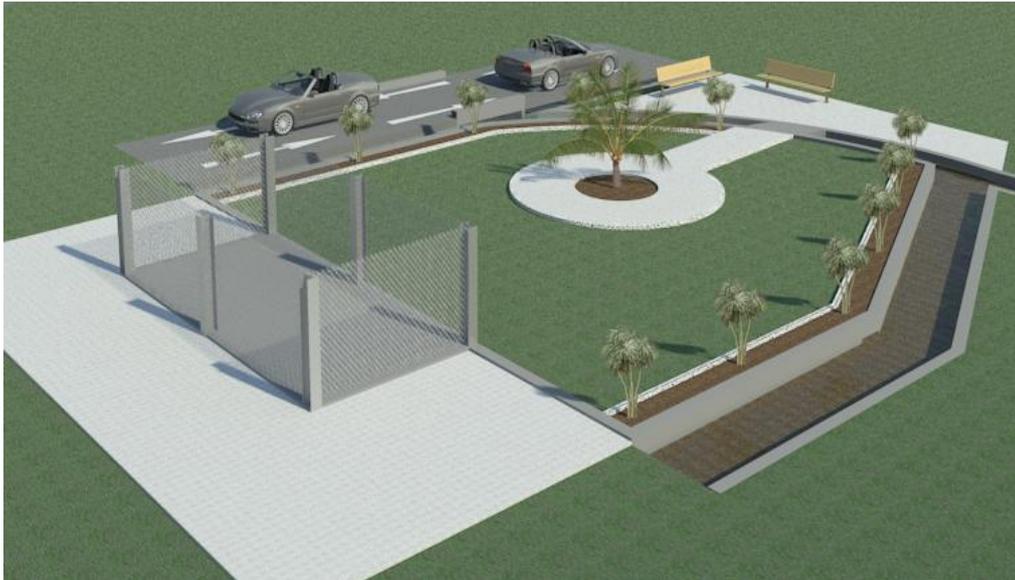
Figure 4a: 3D Render side view of the Alagbafo Natural spring.

4b: 3D Render back view of the Alagbafo Natural spring.

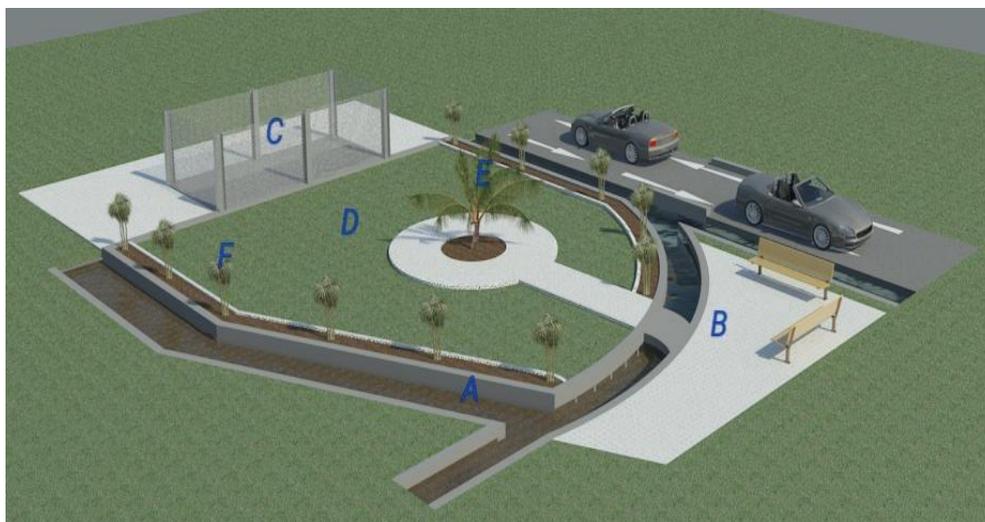
Figure 5: 3D Render left side view of the Alagbafo Natural spring.

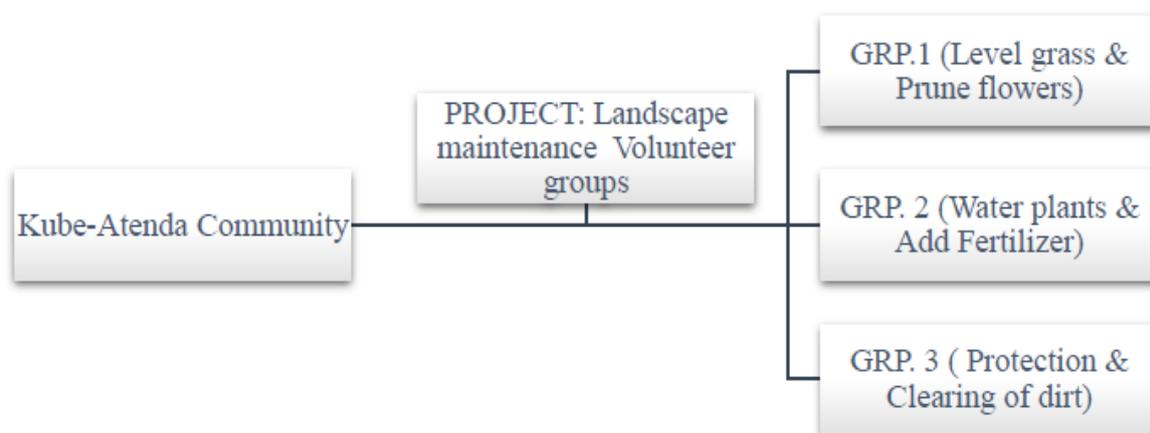
Maintenance is an important aspect in landscaping. Once developed, there is a need to preserve the landscape features in Kube-Atenda community. This can be achieved as a collective effort put together by individuals who are residents of the community by creating groups who can participate in the listed maintenance actions. Individuals should select actions based on their interest only and form groups with those of similar interest. Figure 6 shows a defined structure to which these groups are formed. There are three groups with two maintenances

action paired together. Group 1 consists of those with interest in trimming grass level and pruning of flowers while Group 2 consists of interest in watering and addition of fertilizer and Group 3 consists of interest in clearing of dirt within landscape and prevention of destructive animals such as goats from gaining entry within the premises. Although landscape features require very little or low maintenance, some form of maintenance will be taken but only at an interval period of once in quarter of the year. Maintenance action such as, watering of plants can be done once in a month during dry season as the plants are adaptable to survive without water for a long period of time. Trimming of grass level and pruning of flowers can be once in a quarter of the year. Addition of fertilizer can also be done once in a quarter of twice in the year. Maintenance action that will be required more frequent are clearing landscape of dirt and preventing entry of destructive animals. This can be done with aid of providing a wire mesh around the landscape boundary.

Figure 6: Organogram set up for landscape maintenance.
