**NUMERICAL NONLINEAR ANALYSIS OF PALACKÝ BRIDGE*****Petr Kněž**

This paper presents the results of a nonlinear numerical analysis of the Palacký Bridge. It is a historical arch stone masonry bridge. The bridge was built in 1878 and it is a protected monument. It carries traffic over the Vltava River in Prague. The input for the calculation was a detailed survey of the structure, a load test and historical documents from the time of construction. The aim of the assessment was to determine the influence of the diagnosed defects on the behaviour of the structure

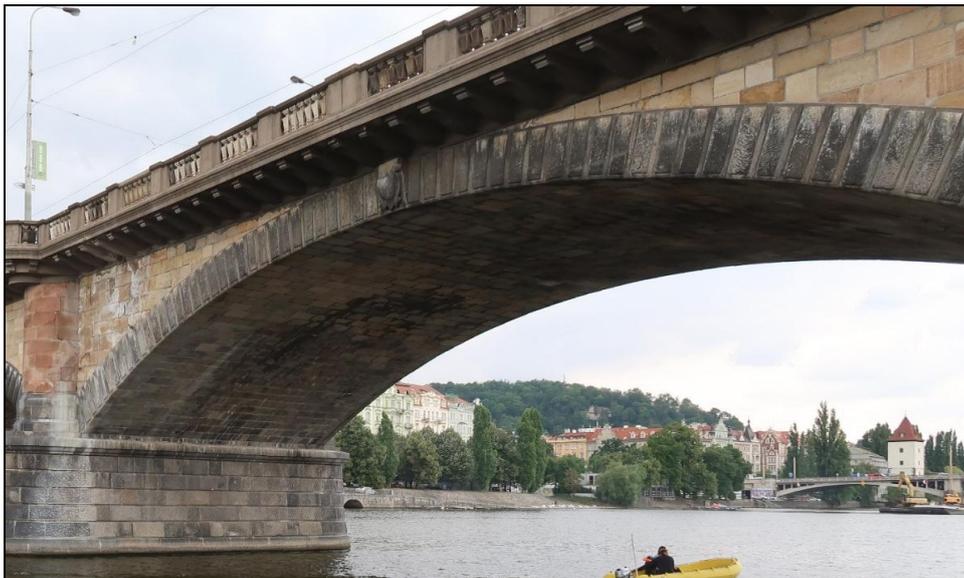
Figure 2: Stone arch of the bridge in detail.

The bridge consists of a total of 7 arches with different spans. They are made of granite blocks and have a span of $27.2 + 28.8 + 30.4 + 32.0 + 30.4 + 28.8 + 27.2$ m. The bridge is 229 m long in total. The ratio of rise to span is always 0.154. The load bearing structure has a variable thickness. The thickness of the granite block masonry is approximately 1.2 m at the top and 1.55 m at the base.

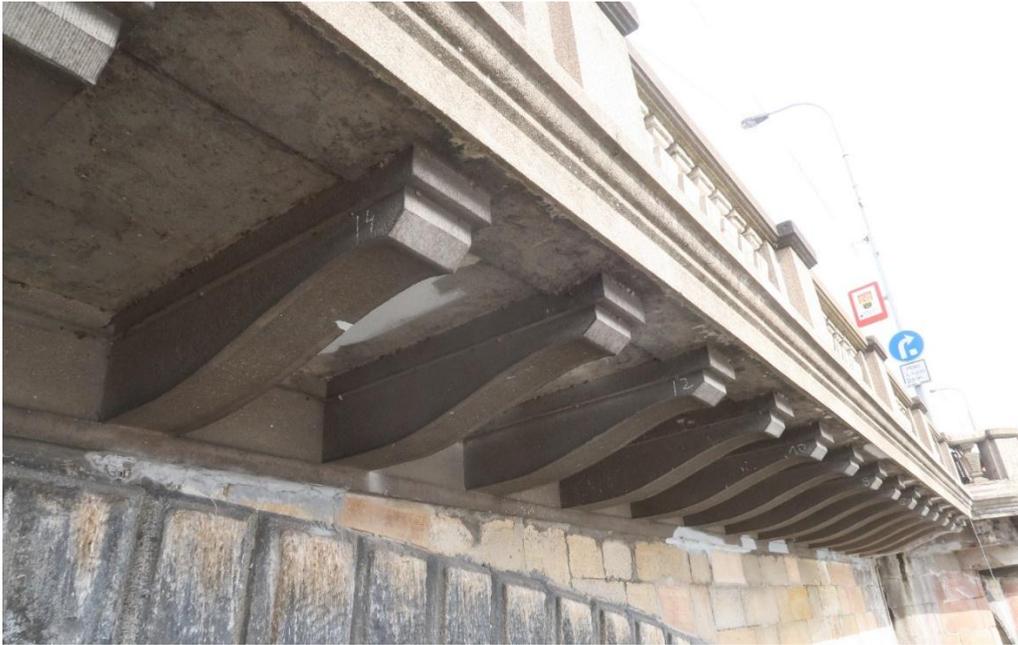
Figure 6: View of the bridge widening.

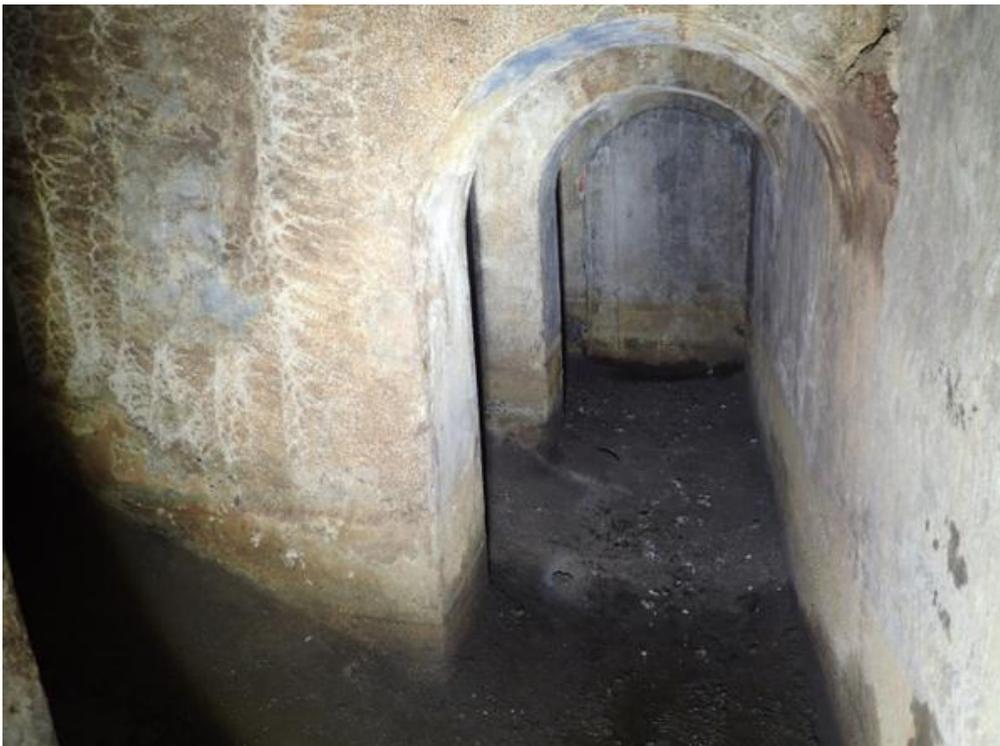
Figure 7: View into the relief chamber.
