EROSION ACCRETION ASSESSMENT OF KUAKATA BEACH USING HISTORICAL SATELLITE IMAGERIES AND BATHYMETRY DATA ADOPTING RS-GIS TECHNIQUE

Dipen Saha^{a*} and Md. Aatur Rahman^b

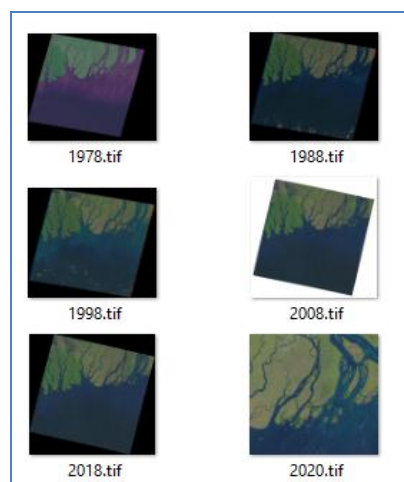
Figure 0.1: Satellite images of different year.

First 6 images are used for coastline shifting assessment and quantifying erosion and accretion which are coarser resolution. As 30 x 30-meter resolution images have been used in this study, so it can be said that accuracy level of the coastline shifting is 30 m.

Satellite images for different year have been downloaded from USGS as listed in the **Table 0.2** and shown in the **Figure 0.1**. All the images are captured by Landsat satellite. Long term (10 years) shifting has been taken under consideration for coastline shifting assessment.

All satellite images are geo-referenced. Total 6 number of satellite images are used in this research works.

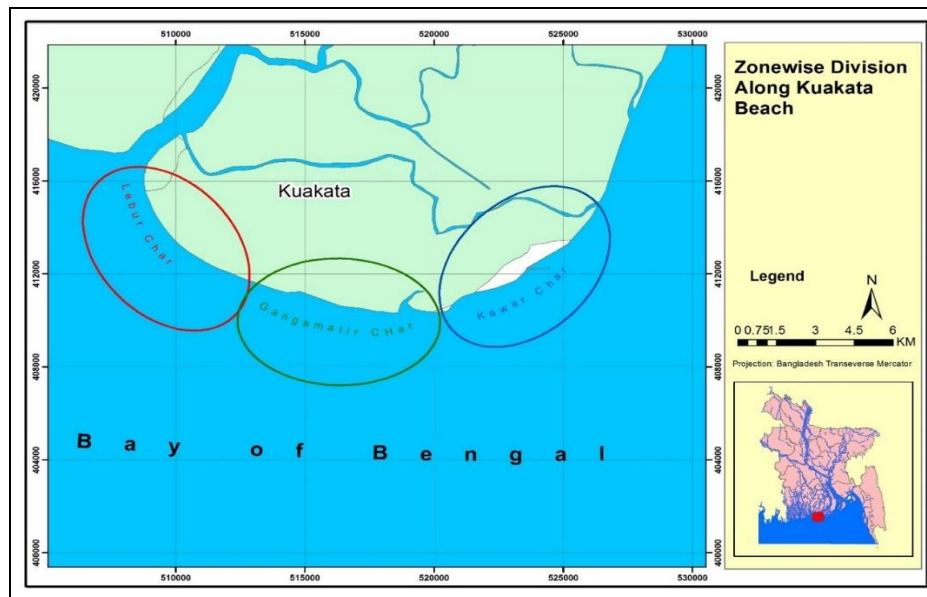
Figure 2.1: Zone wise division along Kuakata beach.

Kuakata beach is 24 Kilometer long. The whole Kuakata beach can be subdivided into three parts by location. The western side is known as Lebur Char, the middle portion is known as Gangamatir Char and the eastern side is known as Kawar Char. The subdivisions of Kuakata beach are illustrated by **Figure 2.1**. In this study shoreline is subdivided into 24 divisions by 1 km chainage interval. Long term (10 years) shifting is measured in each chainage.

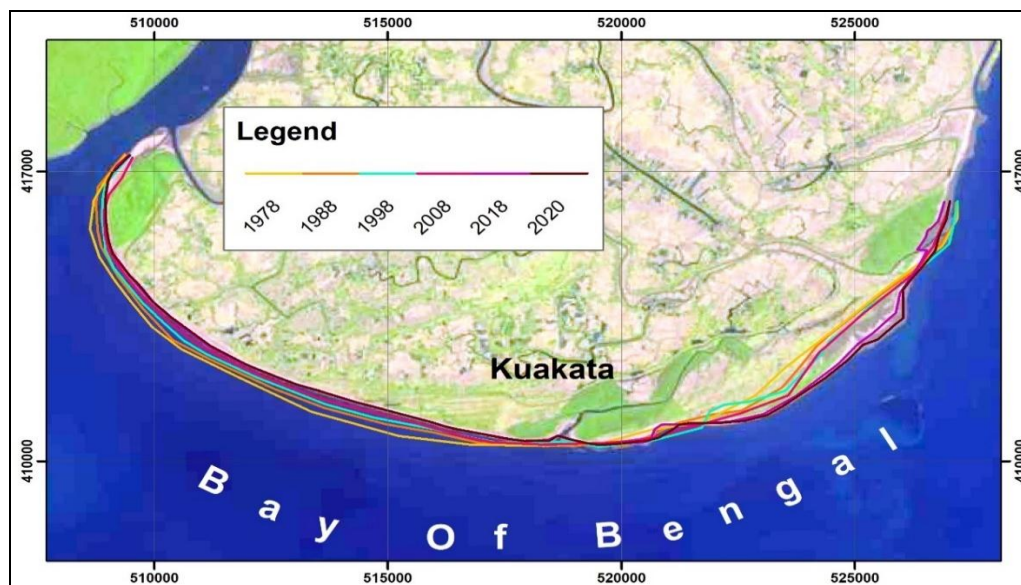
Figure 2.2: Coastline shifting (1978-2020) of Kuakata beach.

As it is mentioned earlier in Chapter 3 that all images are of 30 m resolution. All satellite images are downloaded with the assistance predicted tide by global tide model, essentially in dry season and low tide time which will give accurate coastline line position. Though 30 m resolution imageries can introduce up to 30 m erroneous result, yet it is acceptable for research purpose. Now a days 10 m resolution sentinel images are available by which coastline shifting assessment can be accomplished more correctly. Commercially available high-resolution images can also be used depending on the purpose.

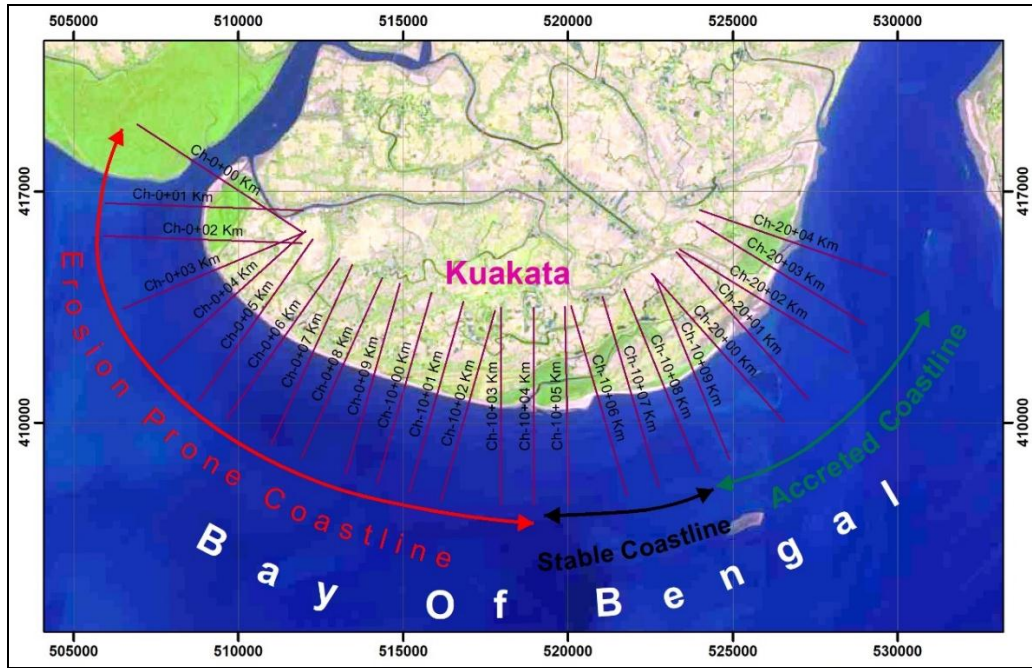
Figure 2.3: Erosion vulnerability of Kuakata beach with chainage.

From the **Figure 2.3**. It is seen that left portion (Chainage-0 to chainage-13 km) is erosion prone coastline, Chainage 13 km to Chainage-17 km is almost stable over the time and Chainage-17 to Chainage-24 is accreted coastline. Total Erosion and accretion area have also been found out from 1978 to 2020. From **Figure 2.4** it is seen that 4.8 sq. km has been eroded and 3.7 sq. km has been accreted in 42 years. So, the erosion rate and accretion rate are 9

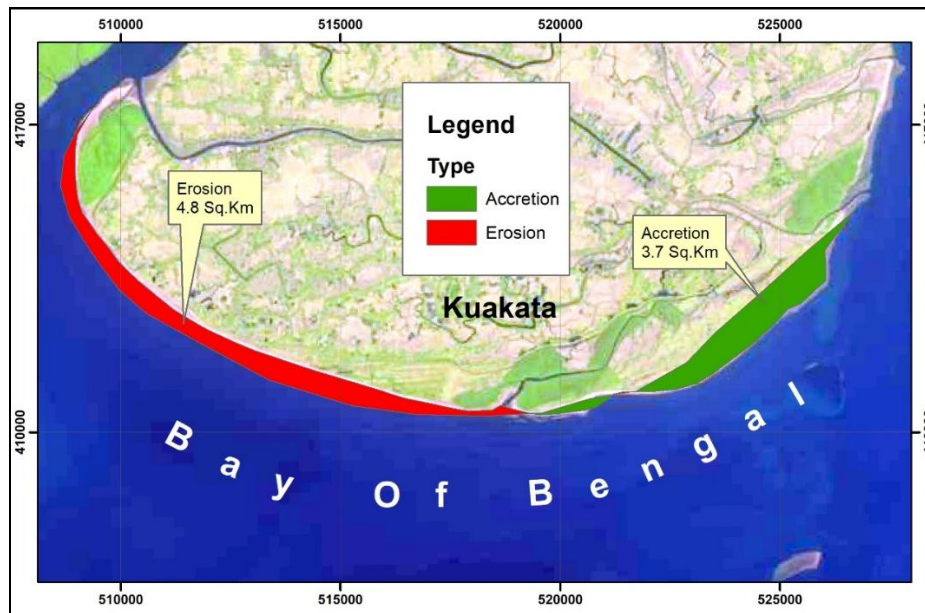
Figure 2.4: Total erosion and accretion of Kuakata beach.

m/yr and 12.2 m/yr respectively. Though erosion area is higher than the accretion, but erosion rate is comparatively lesser than the accretion in Kawarchar area.

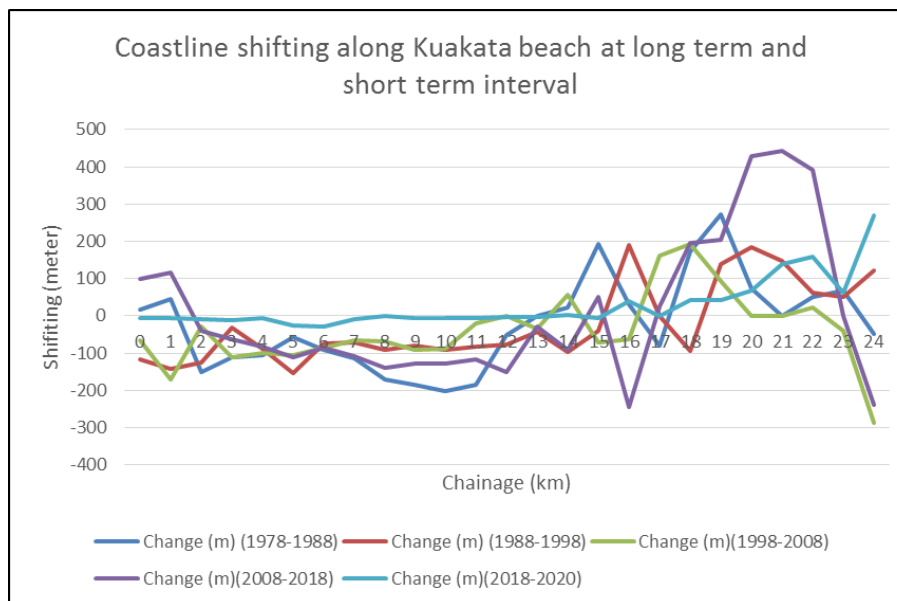
Figure 2.5: Coastline shifting along Kuakata beach at different term.

Figure 2.5 revealed that that western side of Kuakata beach has long history of erosion. Significant accretion is also happening over time in the eastern side. But this can be identified only by long term analysis for course resolution satellite images. In case of short term (2018-2020, 2 years) true result cannot be interpreted because of low resolution. High resolution commercial satellite images are desired for this kind short term analysis.

From **Table 2.1** it is seen that erosion occurs at Lebur Char area which is up to chainage-13 km. In the middle portion or Gangamatir Char bankline is bit dynamic, sometimes it is characterized by erosion and sometimes by accretion. In the east side of Kuakata, Kawar char, is characterized by accretion. Erosion rate is found from table for last 10 years is 11.7 m/yr where accretion in Kawarchar area is 21.2 m/yr. This phenomenon can be depicted from the **Figure 2.5** and **Figure 2.6** as well.

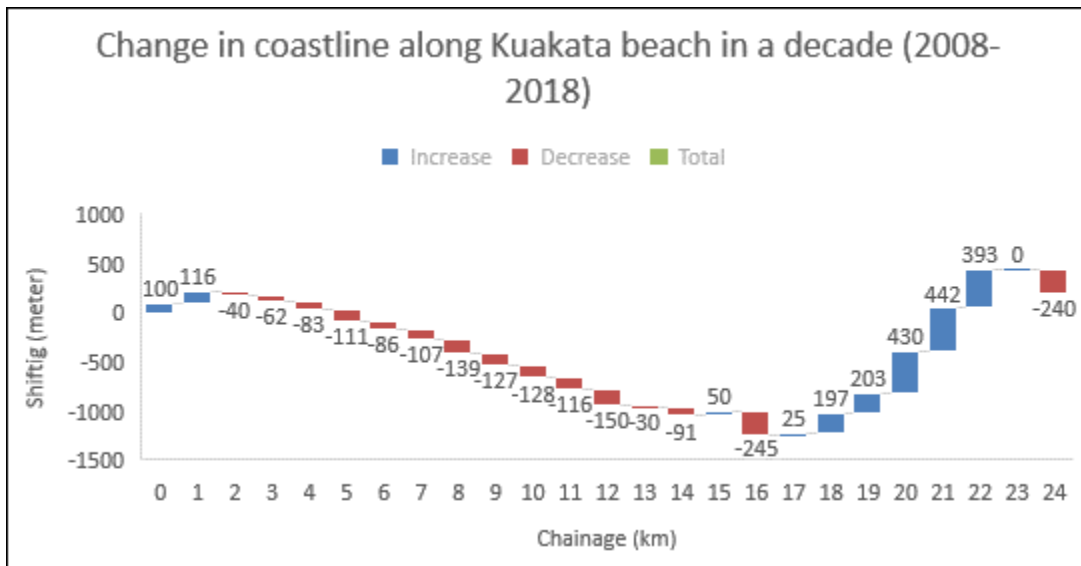
Figure 2.6: Change in coastline along Kuakata beach in a decade (2008-2018).

From the **Figure 2.6** it is evident that during the decade (2008-2018), western side of Kuakata eroded most and maximum erosion (i.e., 128 meter) occurred at chainage 10 + 000 m (10 km). On the other hand, maximum accretion occurred at 21 + 000 m chainage which is about 442 m. Erosion phenomenon is dominant in the western side whereas accretion governs in eastern side along the beach.

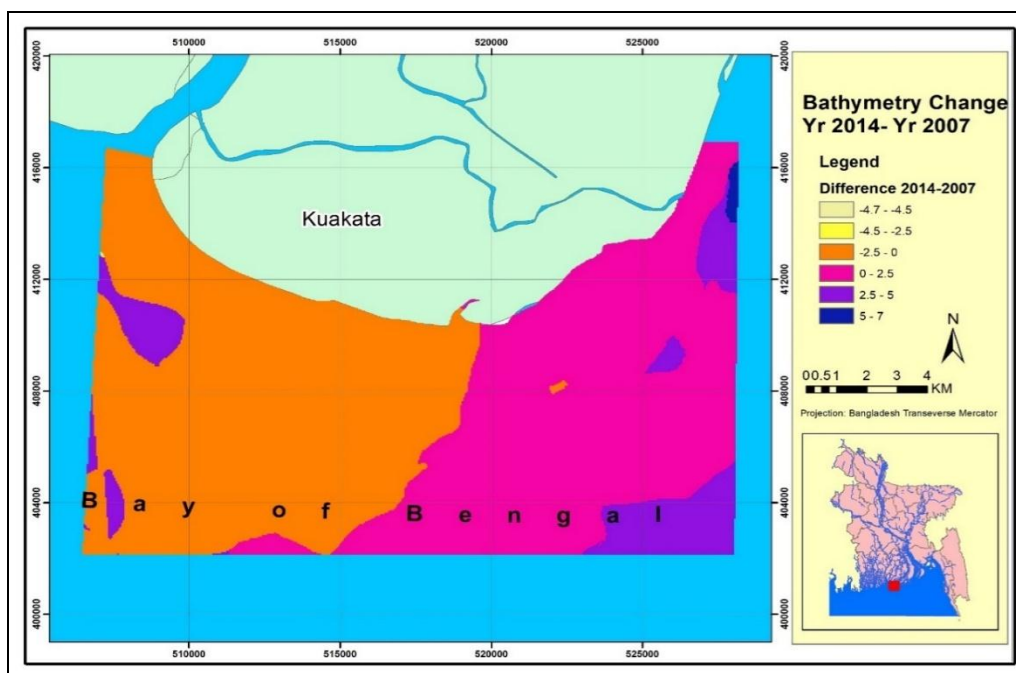
Figure 2.7: Bathymetry change year 2014- year 2007 in the vicinity of Kuakata beach.

Bathymetry of Kuakata beach area has been collected for two years. Bathymetric data for 2007 from C-Map and for year 2014 from GEBCO are superimposed on each other. Using bathymetry data 2007 a raster surface is created by IDW tool of GIS and same thing is done for GEBCO bathymetry data for the year 2014. Raster of 2007 is subtracted from the raster 2014 by raster calculator in GIS which eventually results another new raster and represents the bathymetry change in seven years in the vicinity of Kuakata beach.

From the **Figure 2.7** it is identified that negative value indicates erosion whereas positive value indicates deposition. So, it can be said that western side is dominated by negative value and thus vulnerable to erosion which is shown by yellow color. On the other hand, eastern side is dominated by positive value and thus inclined to deposition phenomena which is shown by pink color. From the bathymetry change it is evident that in the western side of the beach erosion is occurring and on the other hand in eastern side sedimentation occurs which also conforms the result of satellite images analysis.

From historical satellite images analysis, it can be concluded that significant amount of erosion is occurring in the western Kuakata beach and deposition occurs in eastern part which confirms with bathymetry changes of the beach including nearshore. Maximum erosion occurs 202 m and maximum deposition occurs up to 442 m over different decade.
