## THE EFFECT OF EXPOSURE TO COASTAL CLIMATE ON DURABILITY OF LOW-RISE BUILDING ENVELOPES IN NWC (NORTH WEST COAST) RESORTS

## 9. ANALYTICAL STUDY CASE: ZOMORODA VILLAGE RESORT

#### **Comparison Between:** Stone/Brick cladding & Render Finish walls

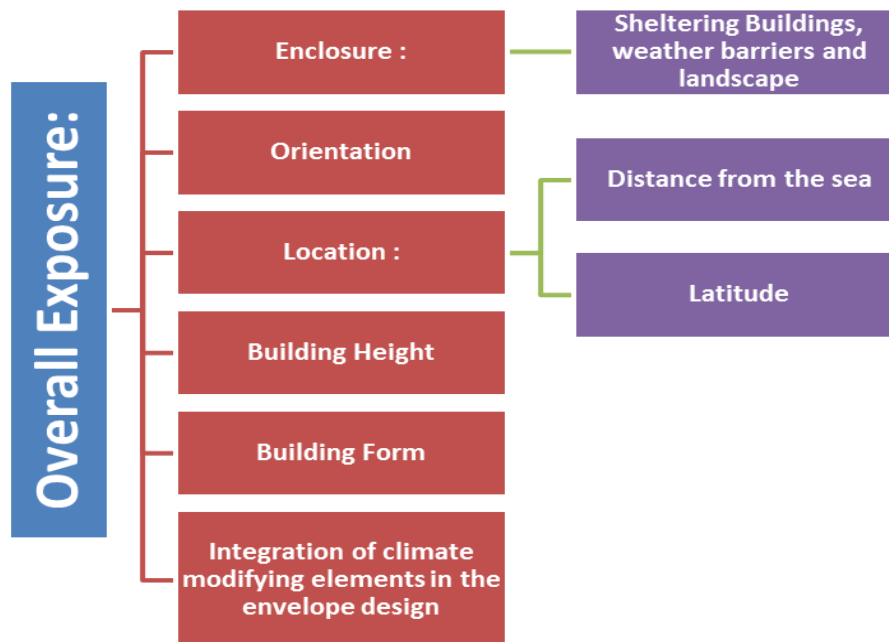
**Fig. 9: The Design Parameters that affect the durability of the exterior finishing materials\*** (Source: The Researcher).

The significant Design Parameters that affect the durability of the exterior finishing materials are presented and summarized in fig.9.

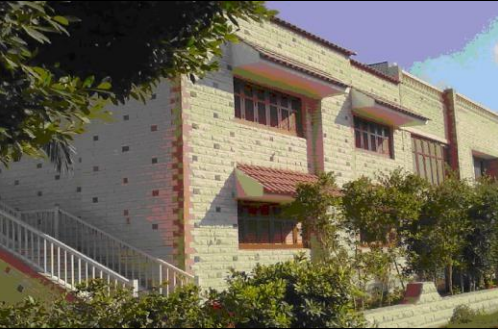
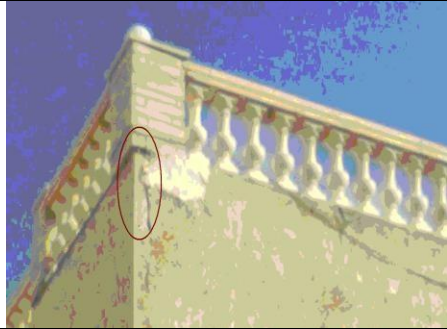
| Location | | Condition and Deterioration features of finishing materials in relation to Building Orientation:<br>Comparison between (Stone / Brick Veneer vs. Rough Render Finish) | | | |
|--|---|---|--|---|---|
| 1 <sup>st</sup> Row | | <p><b>Exposure:</b> Average                      <b>Orientation:</b> South – South West Facades</p> | | Type | Source |

| Location | | Condition and Deterioration features of finishing materials in relation to Building Orientation:<br>Comparison between (Stone / Brick Veneer vs. Rough Render Finish) | | | |
|--|---|---|--|---|---|
| | | <p>- Cladded parts of the wall were found in a very good condition</p> | <p>-Render finished Southern walls :<br/>Cracks at corners due to thermal expansion in non- cladded buildings<br/>- loss of Pigmentation due to UV Radiation</p> | | |

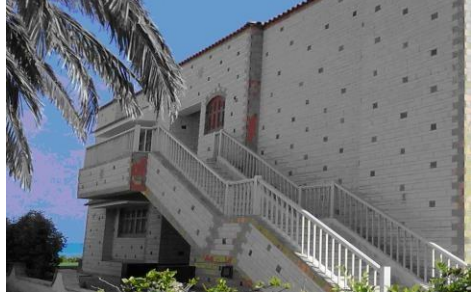
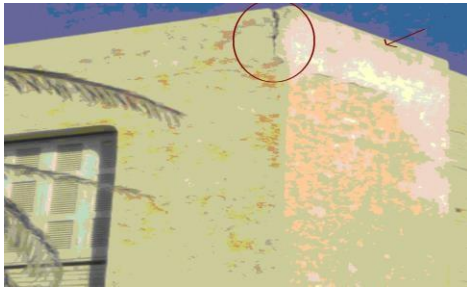
| Location | | Condition and Deterioration features of finishing materials in relation to Building Orientation:<br>Comparison between (Stone / Brick Veneer vs. Rough Render Finish) | | | |
|--|---|---|--|---|---|
| | | <p><b>Exposure:</b> High    <b>Orientation:</b> Western Facades</p> | | | |

| Location | | Condition and Deterioration features of finishing materials in relation to Building Orientation:<br>Comparison between (Stone / Brick Veneer vs. Rough Render Finish) | | | |
|--|---|---|--|---|---|
| <p>- Cladded parts of the wall were found in a very good condition</p> | <p>-Corner cracks in parapet walls due to thermal expansion in non-Cladded buildings<br/>- loss of Pigmentation due to UV Radiation</p> | | | | |

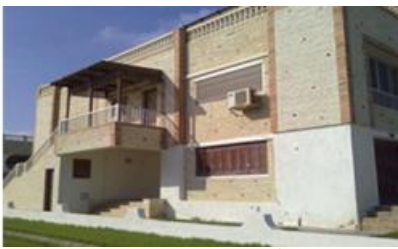
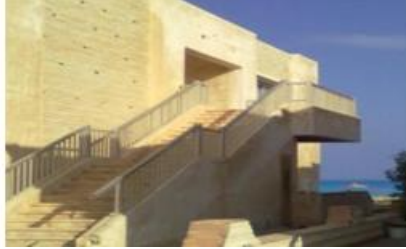
| Location | | Condition and Deterioration features of finishing materials in relation to Building Orientation:<br>Comparison between (Stone / Brick Veneer vs. Rough Render Finish) | | | |
|--|---|---|--|---|---|
| | <p><b>Exposure:</b> High– 1<sup>st</sup> Row-</p> | | <p><b>Orientation:</b> Eastern Facades</p> | | |

| | <ul style="list-style-type: none"> <li><b>Condition:</b></li> </ul> <p>- Cladded parts of the wall were found in a very good condition.</p> | <ul style="list-style-type: none"> <li><b>Condition:</b></li> </ul> <p>-Render Finished parts of the wall were found in fair condition</p> | | | |

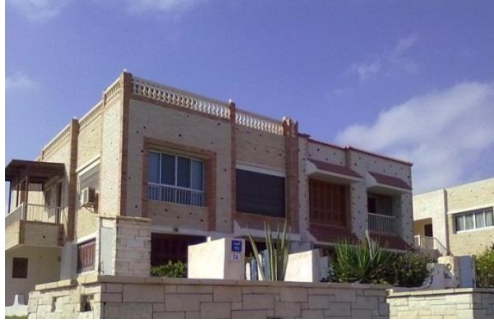
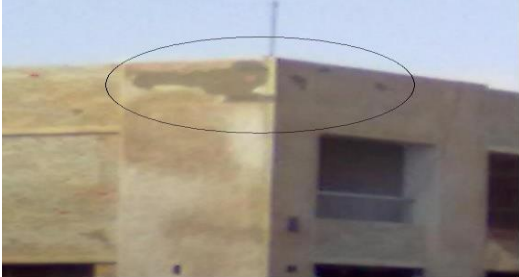
| | <b>Exposure :</b> 1 <sup>st</sup> row | <b>Orientation :</b> North – North East | | | Heat |

| | <ul style="list-style-type: none"> <li><b>Condition:</b></li> </ul> <p>- Cladded parts of the wall were found in a very good condition.</p> | <ul style="list-style-type: none"> <li><b>Condition:</b></li> </ul> <p>-High moisture content in corner parapet wall caused partial peeling in wall render finish due to water ingress at the intersection line between the roof slab and the wall. (Moisture carried by high wind velocities, together with probable accumulation of rain water.)</p> | | | |

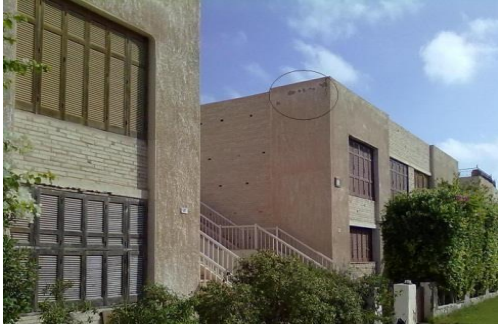
| 2 <sup>nd</sup> Row | <b>Exposure:</b> Average : 2nd row | <b>Orientation-</b> Southern Façade | | Moisture | Driving Rain |

| | | <ul style="list-style-type: none"> <li><b>Condition:</b></li> </ul> <p>High moisture content in corner parapet wall caused partial peeling in wall render finish due to water accumulation on the roof surface and absorption at the intersection line between the roof slab and the wall.</p> | | | |

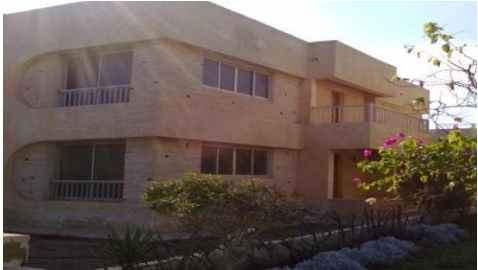
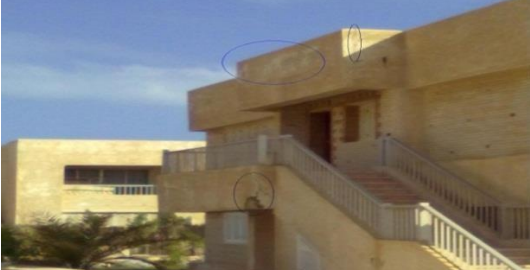
| | <b>Exposure:</b> High:2 <sup>nd</sup> Row: Walkway | <b>Orientation:</b> Western Façade | | | |

| | <ul style="list-style-type: none"> <li>• <b>Condition:</b></li> </ul> <p>- Cladded parts of the wall were found in a very good condition.</p> | <ul style="list-style-type: none"> <li>• <b>Condition:</b></li> </ul> <p>-Efflorescence on parapet wall - and at ground floor walls exposed to garden's moisture and surface water<br/>-Step Crack at the corner of stair case side wall</p> | | |

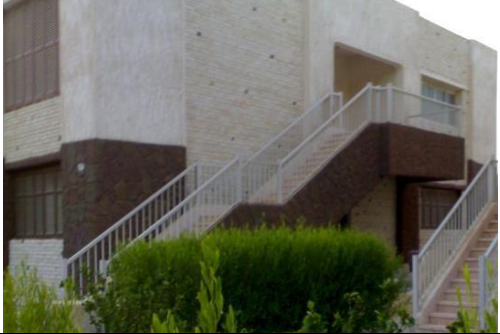
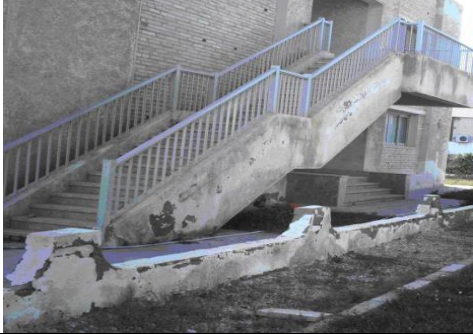
| 3rd Row | <p><b>Exposure:</b> High :<br/>3<sup>rd</sup> Row: overlooking walkway</p> | <p><b>Orientation:</b> Eastern Façade walls</p> | Moisture | Driving Rain, External (Irrigation system) |

| | <ul style="list-style-type: none"> <li>• <b>Condition:</b></li> </ul> <p>- Cladded parts of the wall were found in a very good condition.</p> | <ul style="list-style-type: none"> <li>• <b>Condition:</b></li> </ul> <p>-Faded color due to high exposure to UV.<br/>-slight cracking at the corner of parapet wall<br/>-severe damage to render layer (at the staircase side /parapet wall), at the parts where accumulated driving rain water over flow and fall off the wall side, causing complete wetting of the stair case walls.</p> | | |

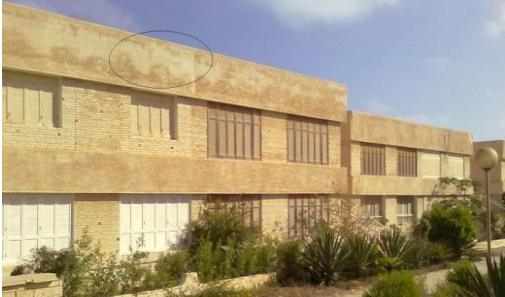
| 4 | <p><b>Exposure :</b> Low -4<sup>th</sup> Row</p> | <p><b>Orientation:</b> Southern Façade</p> | | |

| | <p>No samples were found for this orientation</p> | <ul style="list-style-type: none"> <li>• <b>Condition:</b></li> </ul> <p>- High water absorption during driving rainfall months: parapets absorb most water, and dry out unevenly, leaving wet patches , and efflorescence ,<br/>-color bleach of wall render caused by long exposure to UV radiation externally.</p> | Moisture (wet patches), Faded Color | Driving Rain , UV |

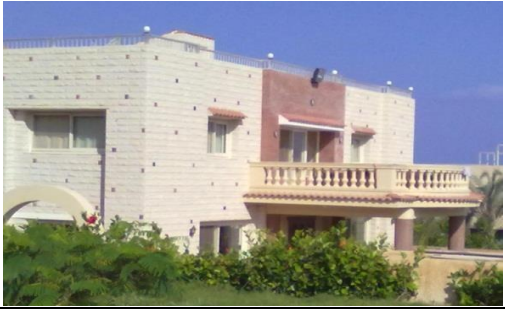
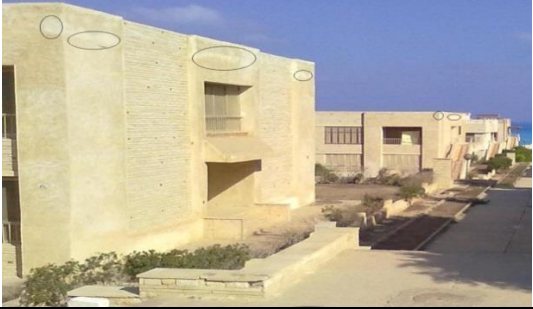
| Exposure: Average: 4 <sup>th</sup> Row | Eastern Façade walls | Moisture (wet patches)<br>Driving Rain |

| • <b>Condition:</b><br>Excellent condition | • <b>Condition:</b><br>Efflorescence and wet marks | |

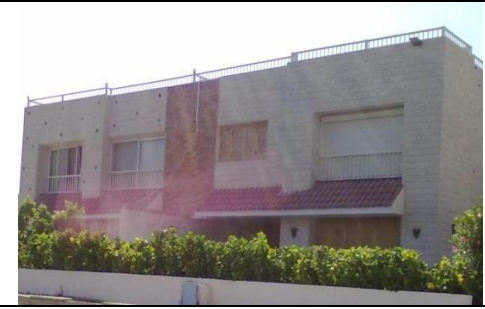
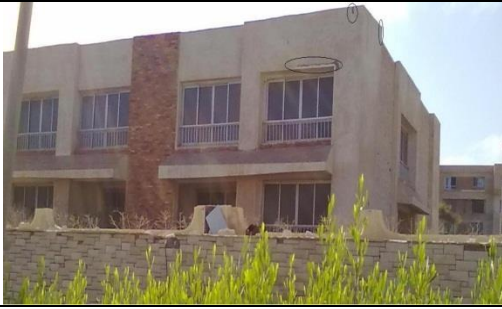
| Exposure: Average | <b>Orientation:</b> North Facade | |

| • <b>Condition:</b><br>- Limestone and brick Cladded parts of the façade (including corners) were in a very Good Condition | • <b>Condition:</b><br>Main damages in Rendered parts are :<br>-Corner cracks in parapet wall and<br>-Partial fracture in the concrete cover of window sills<br>-Partial Peel off of render finish | |
