DIAGNOSIS AND PERFORMANCE EVALUATION OF REINFORCED CONCRETE AND FRP RETROFITTED COLUMNS OF EXISTING BUILDINGS

Dr. Chandrakant B. Pol*

Property Name: Walchand College of Engineering, Sangli.

Inspection date: 15 July 2016 to 15 August 2016.

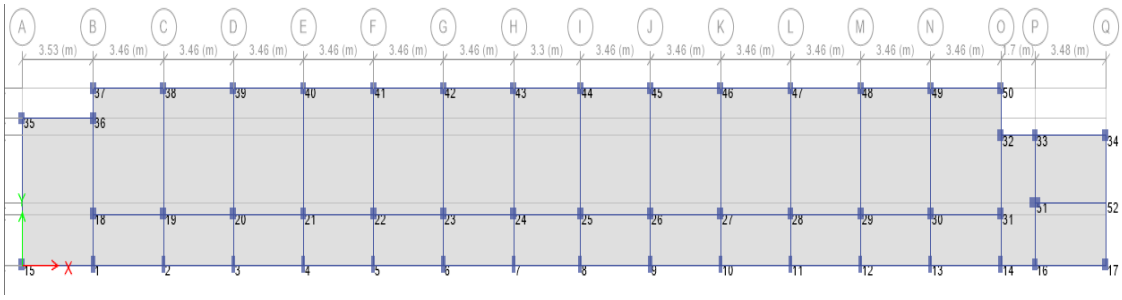
Fig. 7: Highlighting all column nodes of hostel building.

From visual inspection of hostel building it was observed that all column except C2 and C13 are safe.

From the non-destructive test results,it is seen that column C2 and C13 are on the verge of failure. We found that, the reinforcement of column gets degraded and bar dia. Reduced to 6 mm which was earlier 10 mm at the time of construction. So, to analyse these two columns inETABS it is found that these two columns had corroded as maximum of 40% and after degradation the grade of column gets reduced to M10.

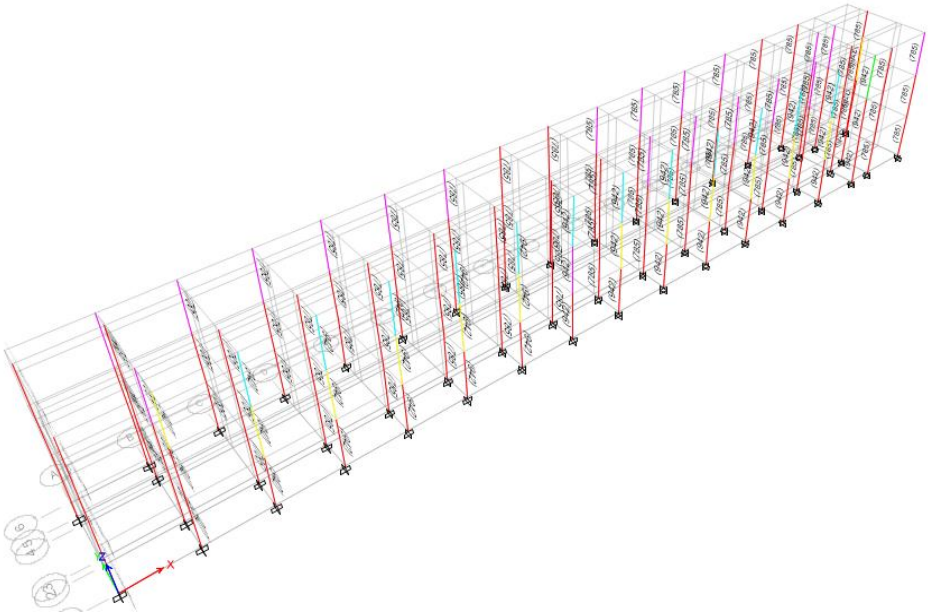
Fig. 10: Columns fails in seismic analysis.

Existing building was not designed for seismic analysis so, all the columns are failed while performing seismic analysis as capacity of members are very less than demanded. From the analysis of existing building it is seen that, for column C2 and C13, % reinforcement is to be decreased from 0.65% to 0.34%. Therefore, from the analysis and non-destructive test results it is found that the column C2 and C13 must have to be retrofitted to avoid sudden collapse.

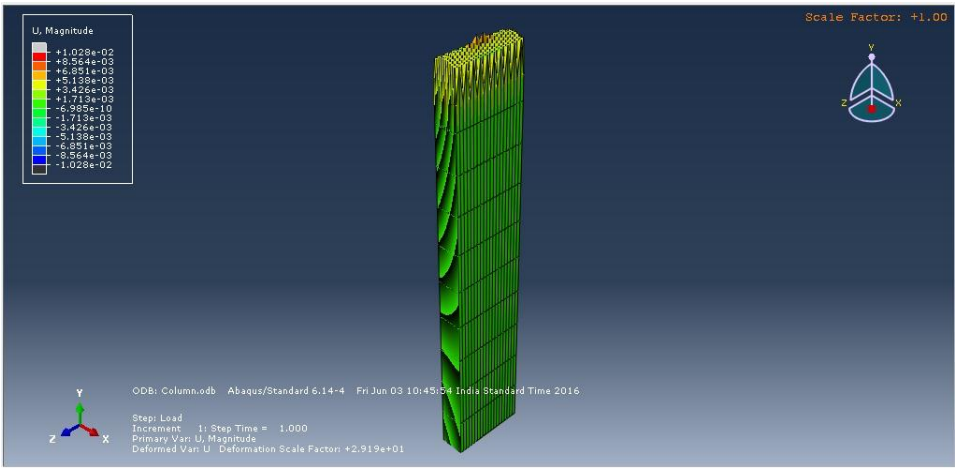
Fig. 14: Analysis of Column after CFRP Wrapping.

2. After application of CFRP, axial load carrying capacity is 742.20 kN
3. Required confining pressure = 13.40 N/mm^2
4. Confining pressure after application is 14.021 N/mm^2
5. Axial strain in confined concrete is 0.012, which is nearly equals to allowable axial strain in confined concrete.
