World Journal of Engineering Research and Technology WJERT

INCREASING DURABILITY OF TEETH OF BUCKLE EXCAVATORS

Ruzibaev Alisher Narkulovich* and Shukurov Rustam Utkurovich

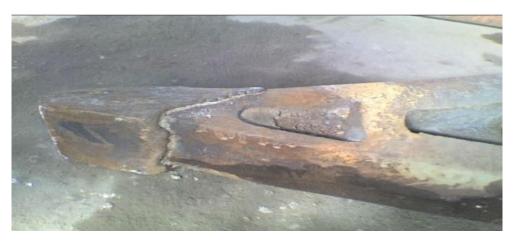
Fig. 2: General view of the teeth of steel welds 50HG.

Among the large number of different methods used to restore and harden the working bodies of excavator buckets, electro-slag surfacing (ESC) occupies a prominent place. This is explained by a number of features of the ESN, namely: the high performance and quality of the weld metal, the possibility of surfacing in a single pass of a layer of almost any thickness, the relative simplicity of obtaining a bimetallic layer or a layer of varying chemical composition. These advantages of ESN over other methods, which appear when surfacing large teeth of excavators, are especially noticeable. Due to the effectiveness of using the methods of electro slag surfacing of volumetric hardening of teeth, an experienced surfacing of worn teeth was performed. Surfacing of the teeth is made on the installation of ES in WRME in NMMC. At the first stage, 110G13L steel was selected for the consumable electrode. At the second stage - steel 50 hg. The surfacing modes remained the same as in the case of surfacing with 110G13L steel, is shown in fig. 2.

Volumetric hardening of the weld cutting parts was performed using heat treatment. The test teeth were subjected to volumetric hardening with heating to a temperature of to = 840 - 8600 C, a holding time in the furnace for 3 hours and cooling in oil. Then the set of teeth got a high tempering at a temperature of to = 420 - 4700 C, aging in the furnace for 3 hours, followed by cooling in air. The second set of teeth went through low tempering at a temperature of to = 200 - 2400 C, exposure to the furnace for 3 hours and cooling in air. After heat treatment, the hardness of the metal of the deposited cutting part of the tooth, which passed the low tempering HB = 460.

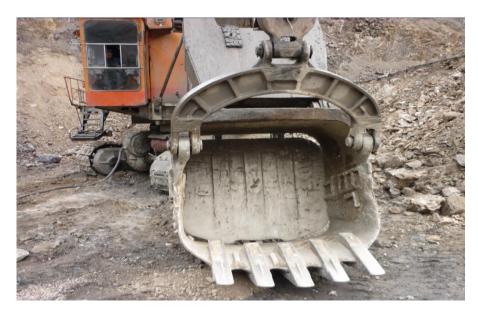
Fig. 3: General view of the front wall of the bucket with established teeth on it. CONCLUSIONS

One of the ways to increase durability, we consider the constructional method, it is to change the shape of a tooth to the place of a standard wedge-shaped tooth, we propose a three-sided molded tooth. With operational tests in the Karakutan quarry, the triangular tooth had a

resource compared to a standard tooth 15 to 23% more. Figure 3 shows a general view of the front wall of the bucket with the experienced teeth mounted on it.

Triangular wedge teeth actively penetrate into the rock, as if joining into it with a high specific pressure, therefore, with the least resistance and as they move further, they destroy the rock by continuous puncturing of the cutting edge. The front three facets, the back and side faces, displace the rock particles above and below the tooth, or force them out of the area where the teeth act, or press them into the less dense layers of the rock being developed. Vertically located third gran in the process of rock destruction plays the role of a rock splitter, as well as changes in the trajectory of abrasive rocks and contributes to the stability of the tooth with the bucket.
